**PHASE I ENVIRONMENTAL ASSESSMENT
1438 CAPITOLA ROAD
SANTA CRUZ, CALIFORNIA**

Prepared by:
Remediation Risk Management, Inc.
P.O. Box 1362
Aptos, California 95001

6 June 1994

REMEDIAL ACTION SUMMARY REPORT

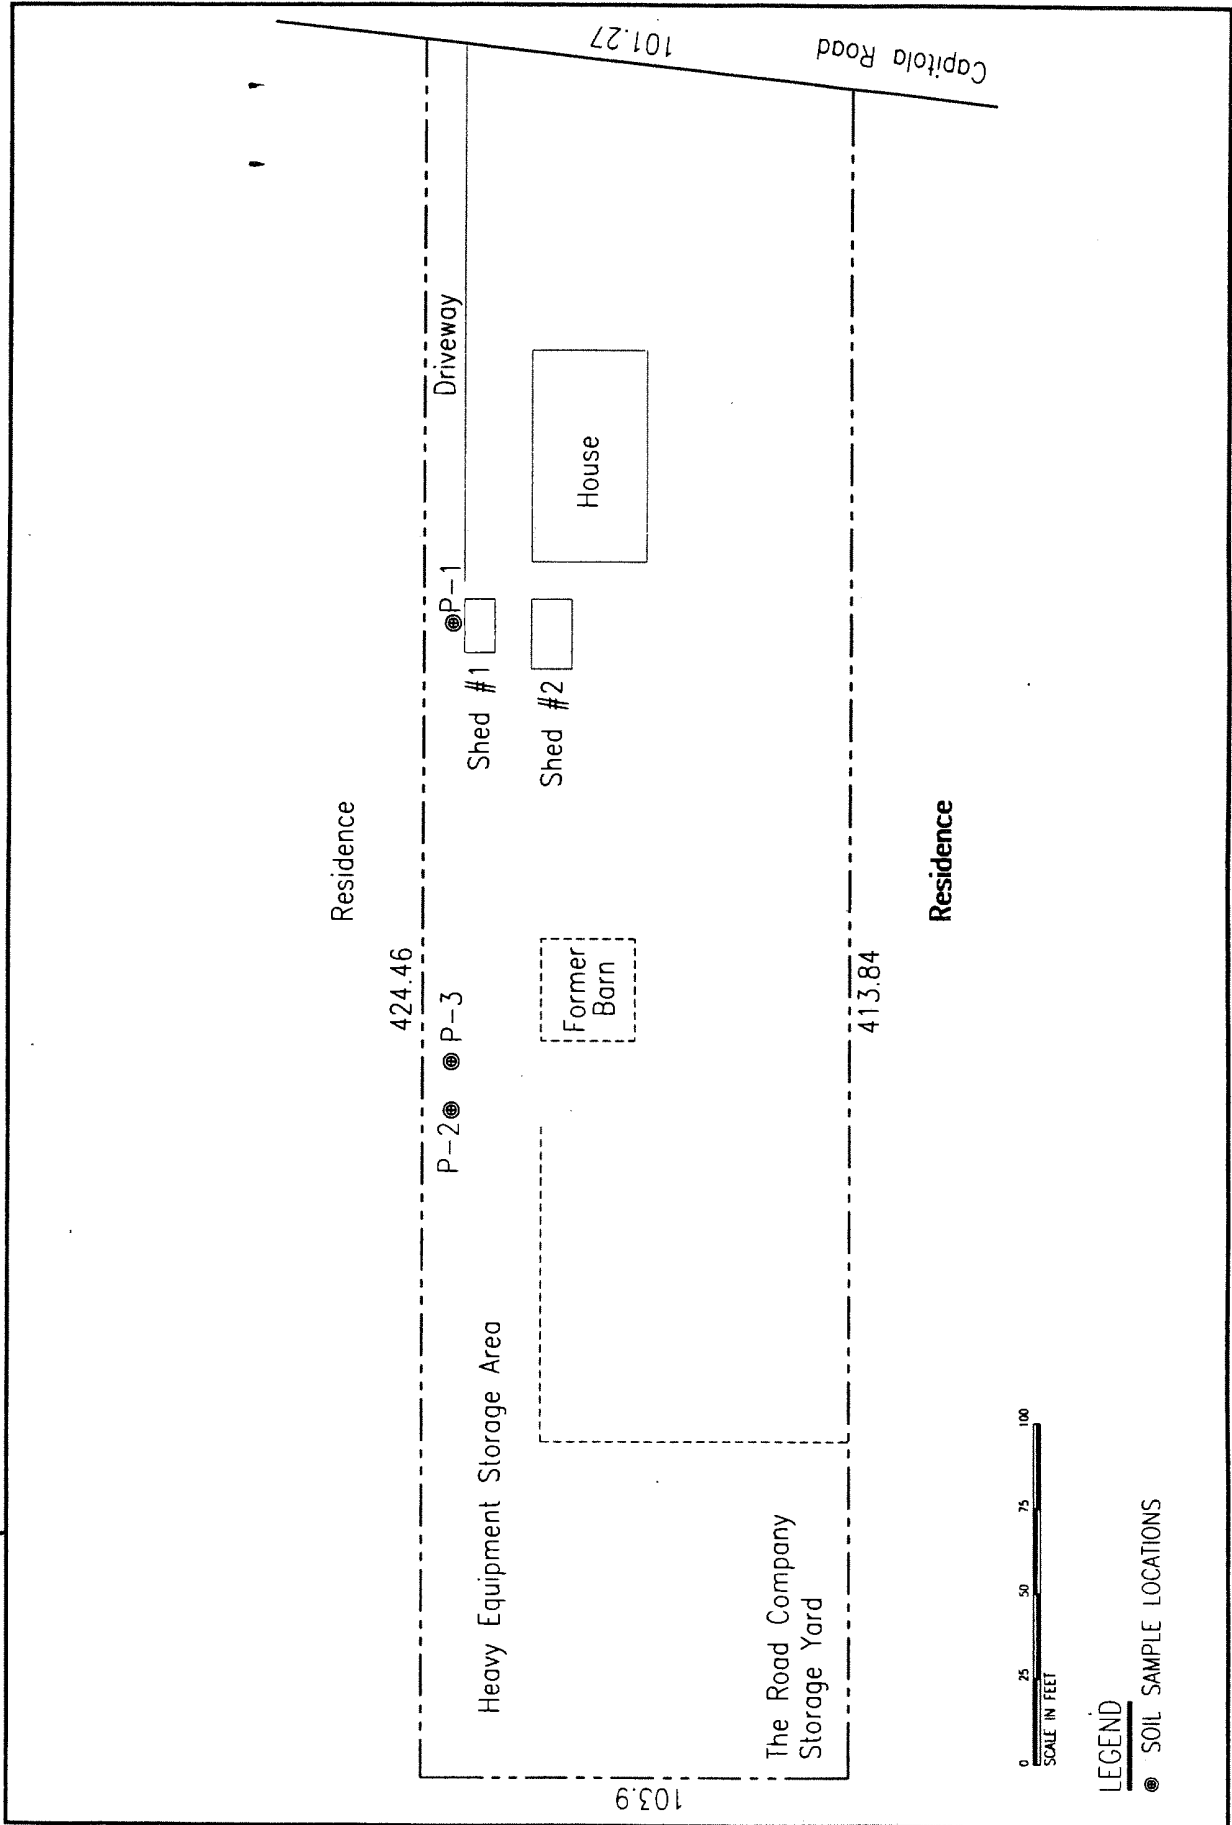
EXTENDED SITE PLAN
 1438 Capitola Road
 Capitola, California

Above ground storage tanks - There is one approximately 1,500-gallon above ground storage tank located in the south central portion of the property (See Site Map, Figure 2). Jim Johnson stated that the tank is used to haul asphalt slurry from a supplier to the job site. The tank is used as a mobile tank and normally is empty when it is returned to the sight. No stains were noted surrounding the tank area. The tank appears newer and in good condition.

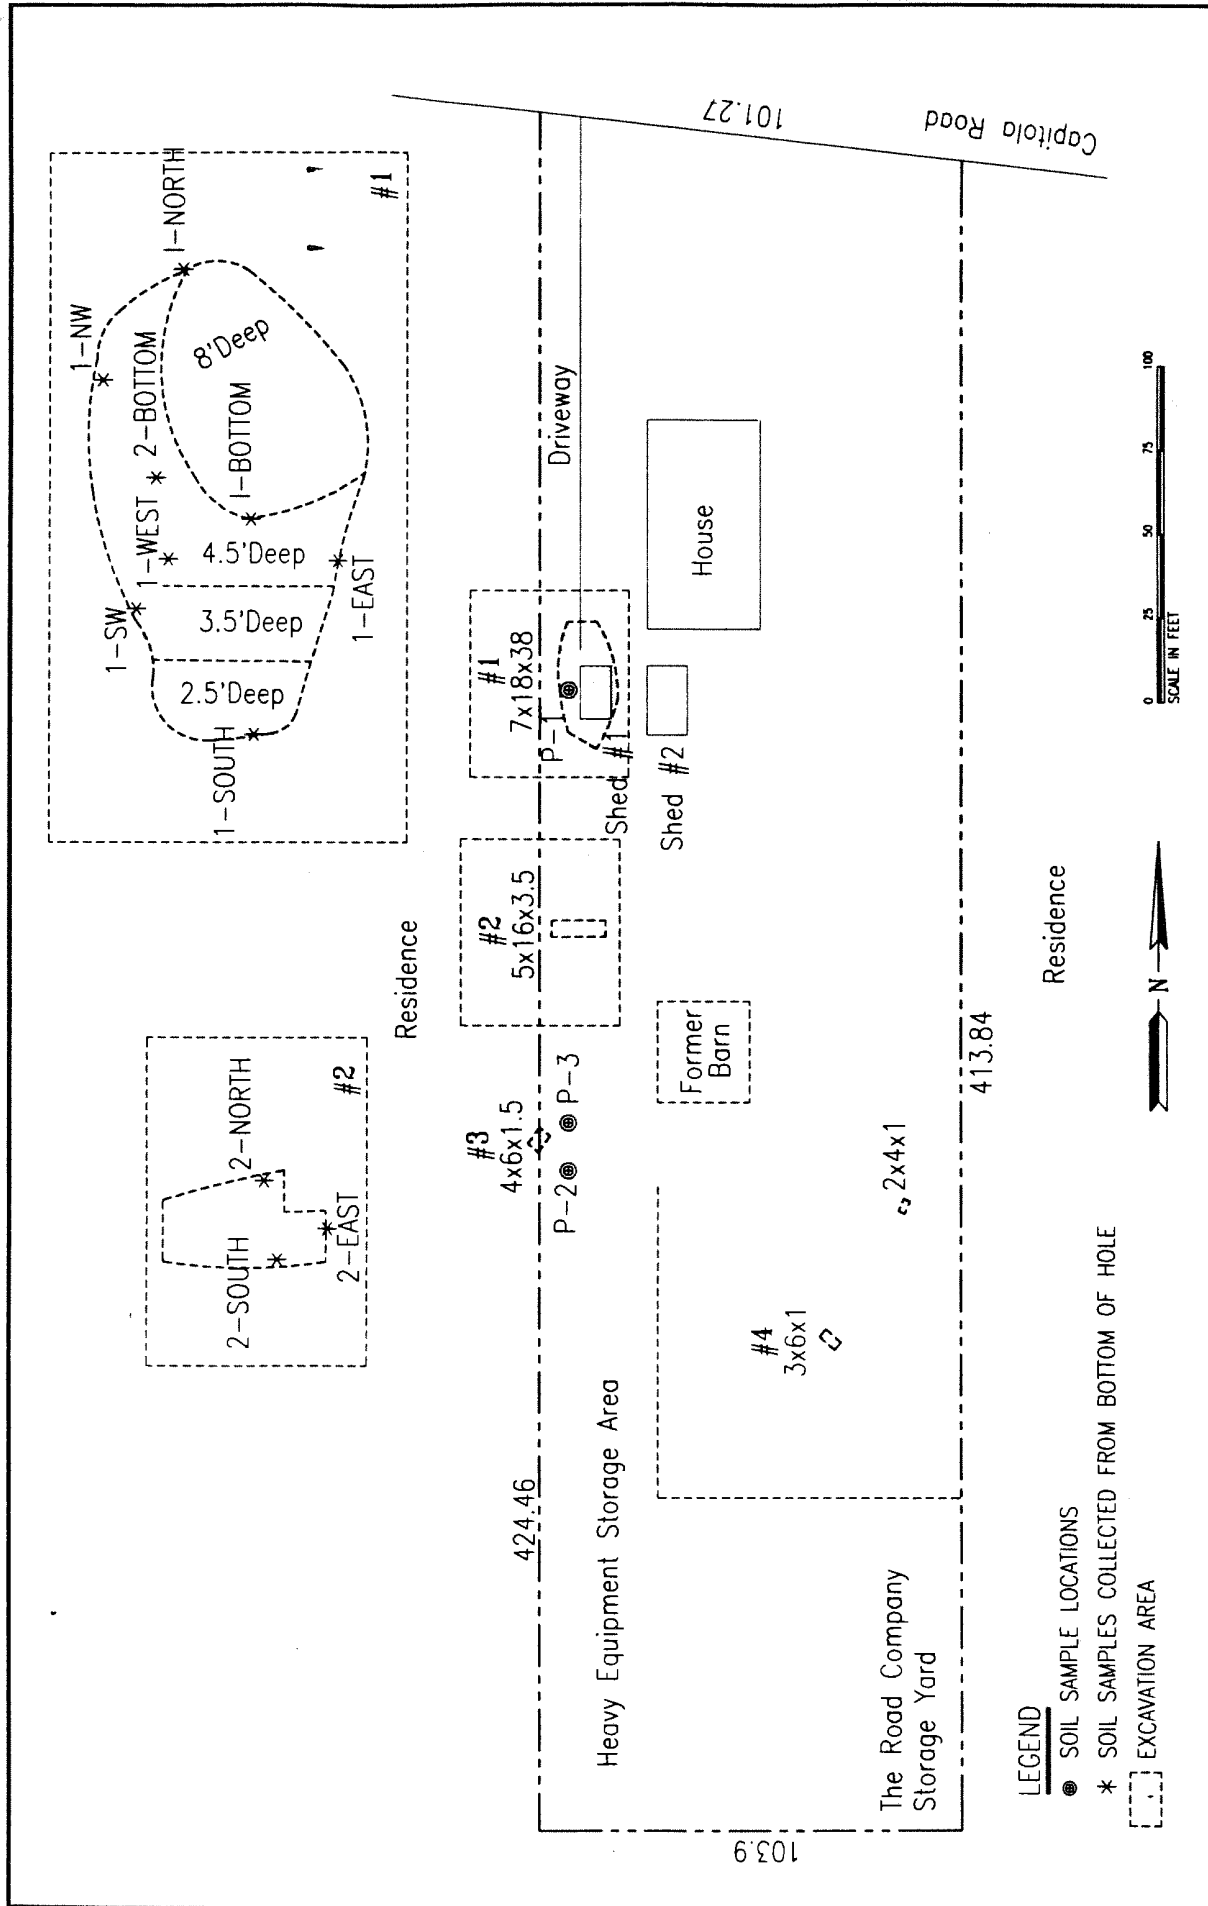
EXCAVATION SITE
 1438 Capitola Road
 Capitola, California

The initial excavation activities conducted on September 2, 1994 removed 130 tons of soils. However results from the soil sample collected from the west sidewall of the excavation indicated concentrations of 700 ppm as diesel were present. Additional excavation was completed at excavation #1 on September 21, 1994 to remove the remaining contamination. Additional confirmation soil samples were collected and submitted to Hull Developmental Labs.

Soil sampling analyses indicate that the contaminated soils have been removed to non-detectable levels in the areas of concern.

A licensed backhoe operator contracted by the owner, excavated and removed soils from the previously identified impacted areas and areas where surface staining was evident. Excavation activities were supervised by an RRM staff geologist. Excavations were conducted in five areas, designated as excavations #1, #2, #3, #4, and #5 in Figure 3. Soils were scraped/and or removed from each area until there was no visual or olfactory evidence of petroleum hydrocarbon contamination. Jose DeAnda, with Santa Cruz County Environmental Health Department, inspected the site during excavation and soil sampling activities. Approximately 130 tons of contaminated soil was excavated. The soils were stockpiled on-site, and covered with visqueen sheeting. Following acceptance approval by the county of Santa Cruz the owner hauled all excavated soils to Buena Vista Sanitary landfill in Watsonville, California for disposal. The disposal receipts are provided in Appendix A. The excavations were reportedly backfilled by the client with clean fill material.
