Nigel Belton

Consulting Arborist

**AN ASSESSMENT OF THE TREES LOCATED WITHIN THE PROPOSED DEVELOPMENT SITE
AT 1412, 1438, 1500 AND 1514 CAPITOLA ROAD, SANTA CRUZ - CALIFORNIA**

Site visit by:
Nigel Belton - ISA Certified Arborist WE-0410A
July 16, 2018

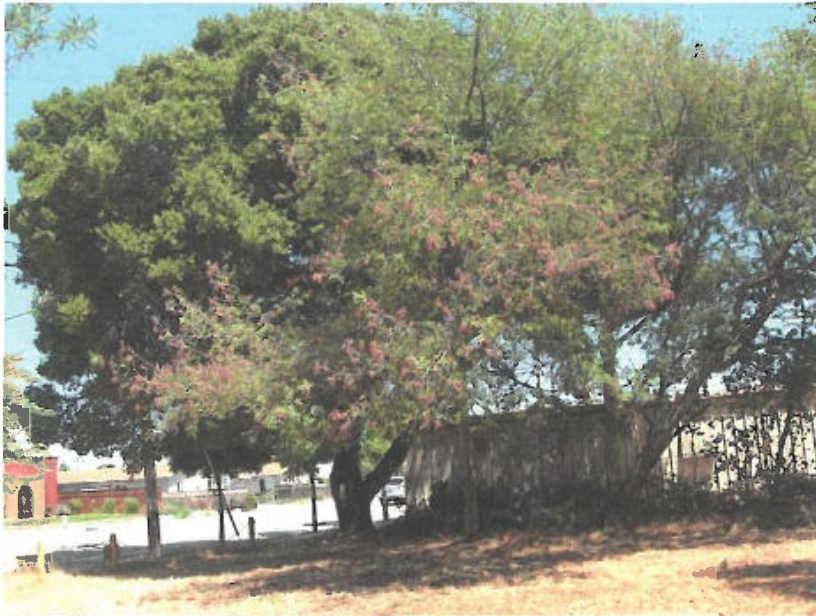
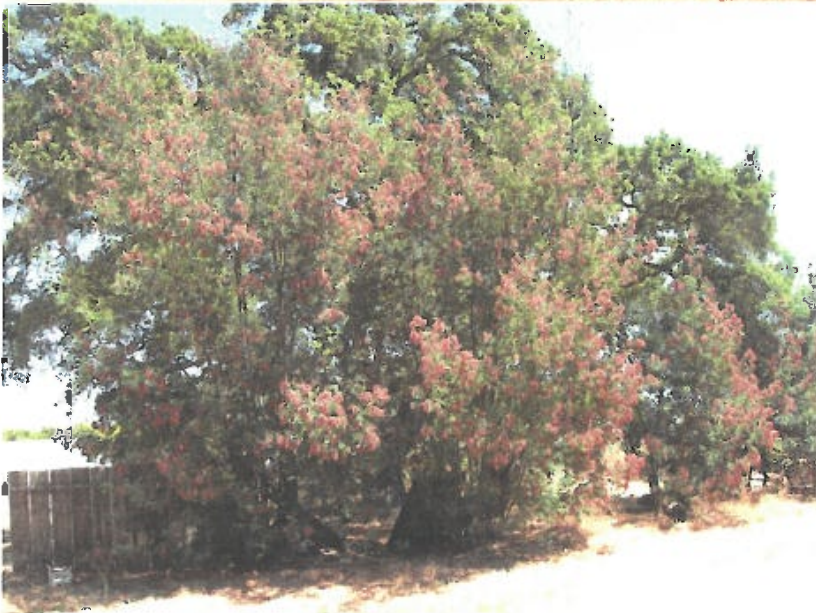
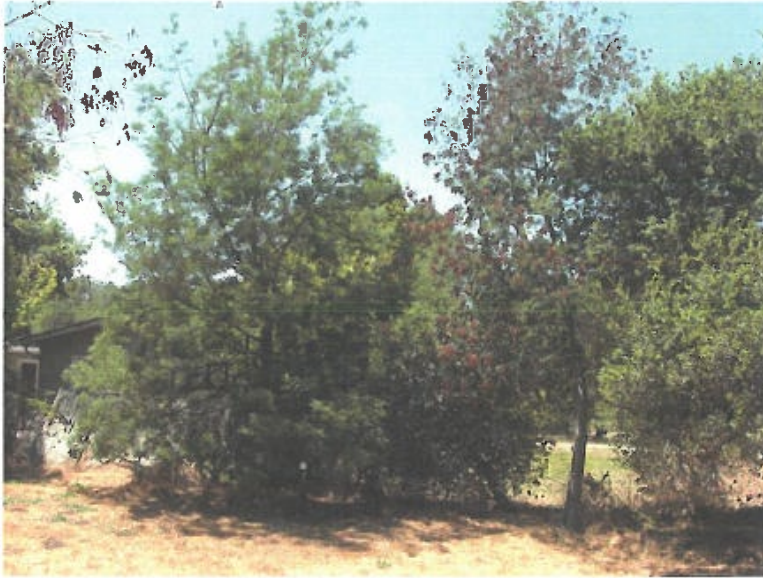
Tree's #2, #4, #6, #19, #21, #22, #32, #33 and #71 - Nine Bailey Acacia (*Acacia baileyana*):

The great majority of the Bailey Acacia trees on this site exhibit poor health and have poor structural conditions. This species is undesirable due to its invasive nature. All of the Bailey Acacia Trees on this site are recommended for removal.

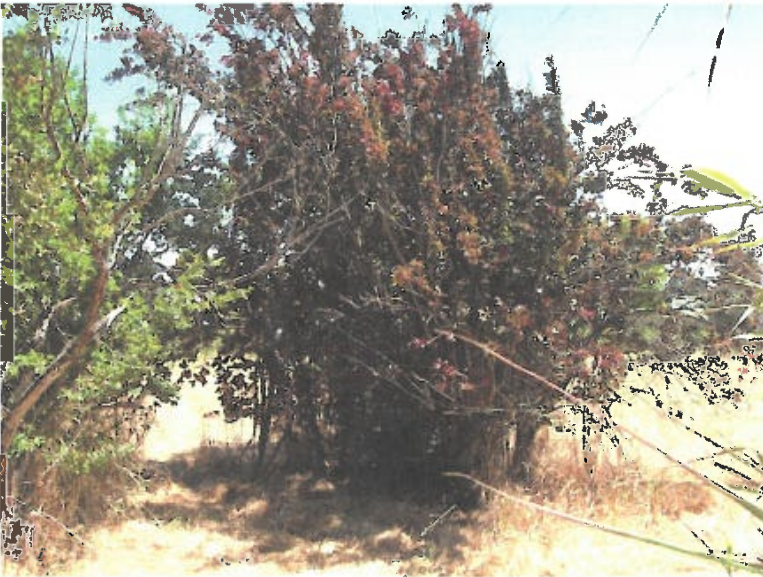
Tree's #10, #17, #20, #23 and #72 - Five Wild Plum Trees (*Prunus spp.*):
Tree #11 - Purple Plum (*Prunus cerasifera*):

These Wild Plums comprise of clusters of individual trunks. All of the plums are recommended for removal because they are potentially invasive and have poor health and structure ratings.

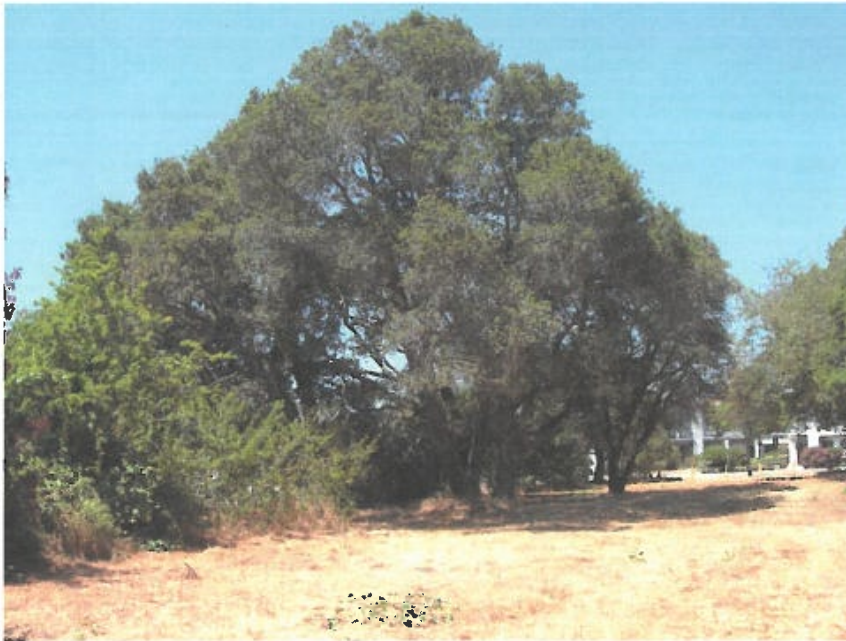
Tree #26 - 20-inch DBH Coast Live Oak:

This tree is located within the grouping of oaks located to the east of the residence at 1500 Capitola road (Tree's #24 through #31). The six of the larger oaks within the group of trees are recommended for preservation and protection during the design and construction periods of this project.

I recommend that tree #26 is pruned to improve its structure and appearance. Remove larger dead wood and reduce end-weight in any heavy and overextended limbs (also referred to as end weight reduction in this report).

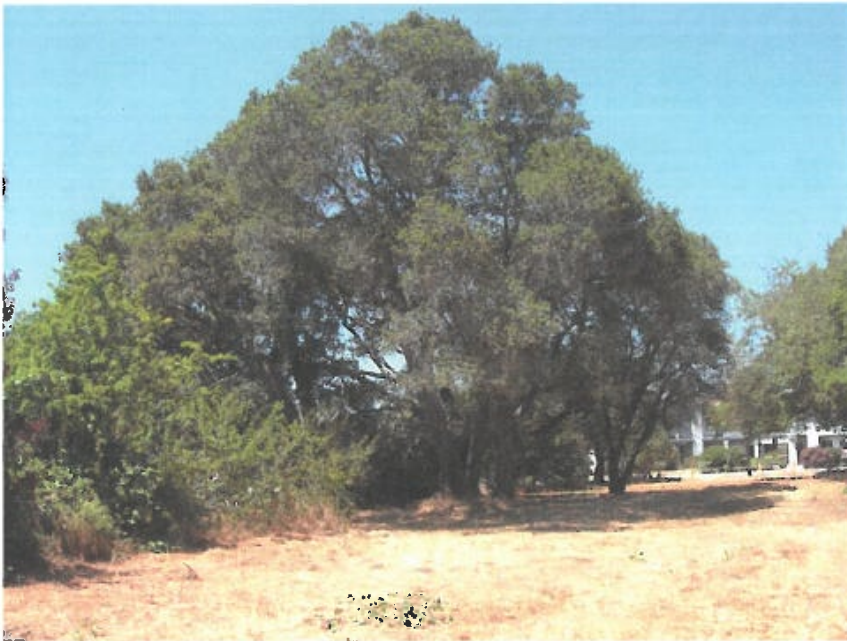
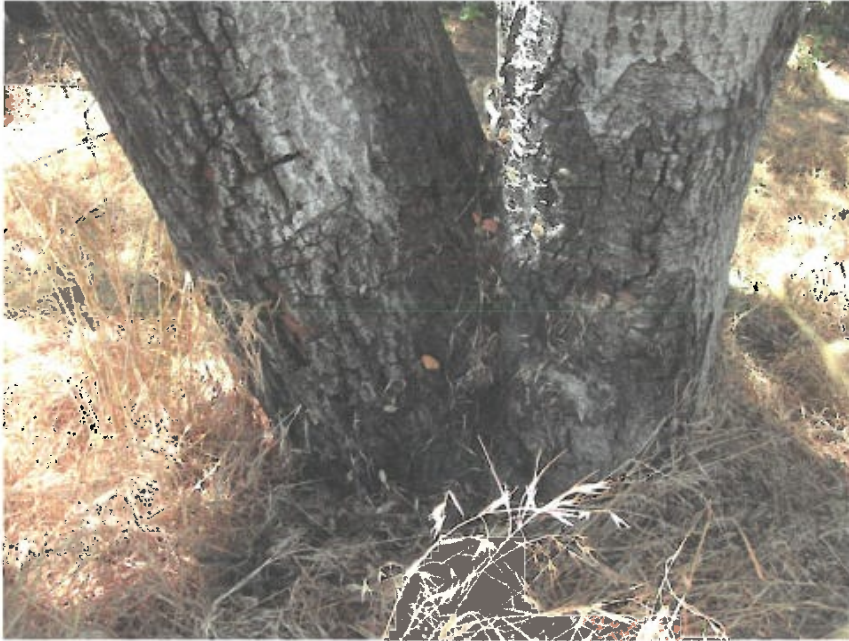
Tree #27 - 20, 17 & 8-inch DBH Coast Live Oak:

This oak has a poor structural condition due to its codominant growth pattern which comprises of three trunks attached to a common stump. The areas of attachment between these trunks are weak and they are vulnerable to failing at this time.

I recommend that this oak is preserved and protected during the design and construction periods of this project.

I recommend that this oak be pruned to improve its structure (reducing weight in the ends of heavier limbs and the remove larger dead wood). I also recommend that one or more support cables are installed between the codominant trunks in order to reduce the risk of trunk failures. Utilize 5/16-inch diameter EHS Grade Cable attached to 3/8-inch through rods, with amon-eyes as the attachment points.

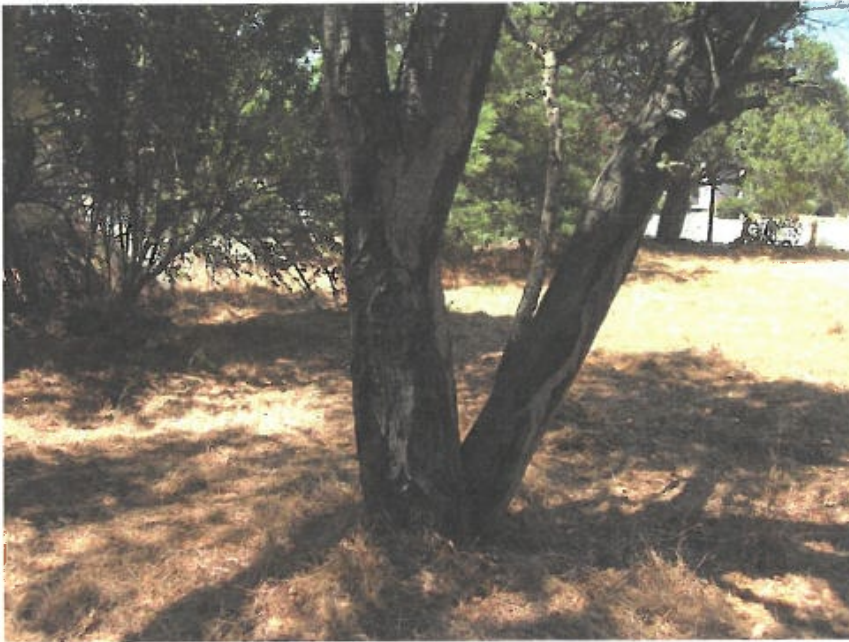
I recommend that this codominant oak is preserved and protected during the design and construction periods of this project.

I recommend that this tree is pruned to improve its structure and appearance. Remove larger dead wood and reduce end-weight in any heavy and overextended limbs.

I also recommend that one support cable is installed in between the two codominant trunks. Utilize 5/16-inch diameter EHS Grade Cable attached to 3/8-inch through rods.

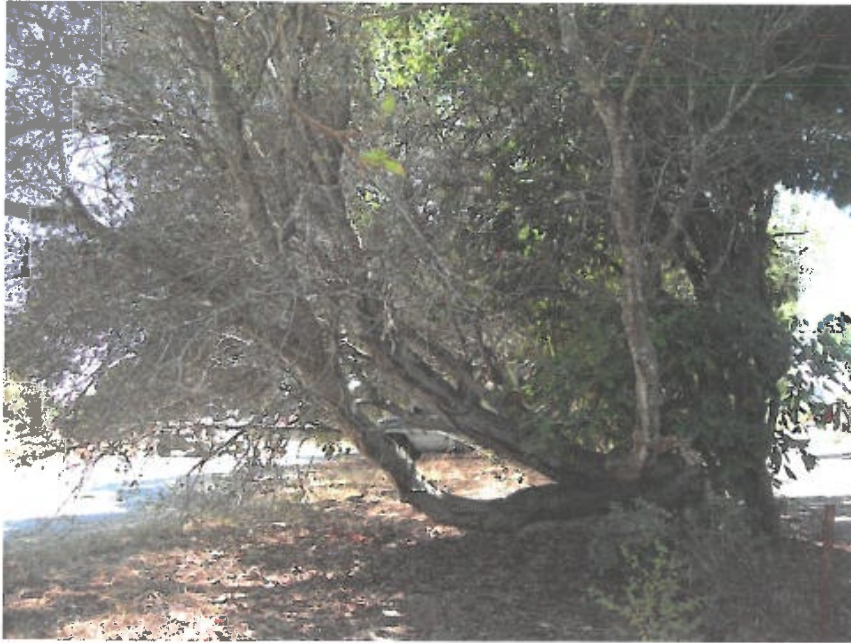
Tree #45- 12 & 10-inch DBH Coast Live Oak:

Located to the west of the house at 1500 Capitola road.

This oak is recommended for removal due to its poor structural condition. It has a poor codominant structure, having two scaffold limbs that are poorly attached at the common trunk. The oak has also developed an asymmetrical growth pattern resulting in a poor canopy shape.

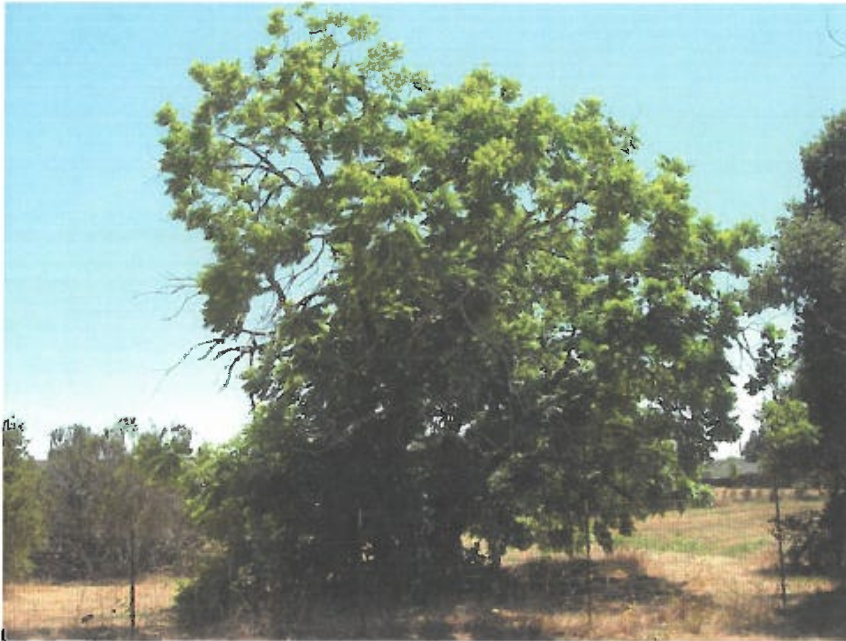
Tree #51 - 7, 8, 5, 5 & 5-inch DBH Black Walnut (*Juqians spp.*):

Tree #55 - 11, 11, 8 & 8-inch DBH Black Walnut:

Both of these Walnut trees are recommended for removal because they have regenerated from stumps and have poor structures.

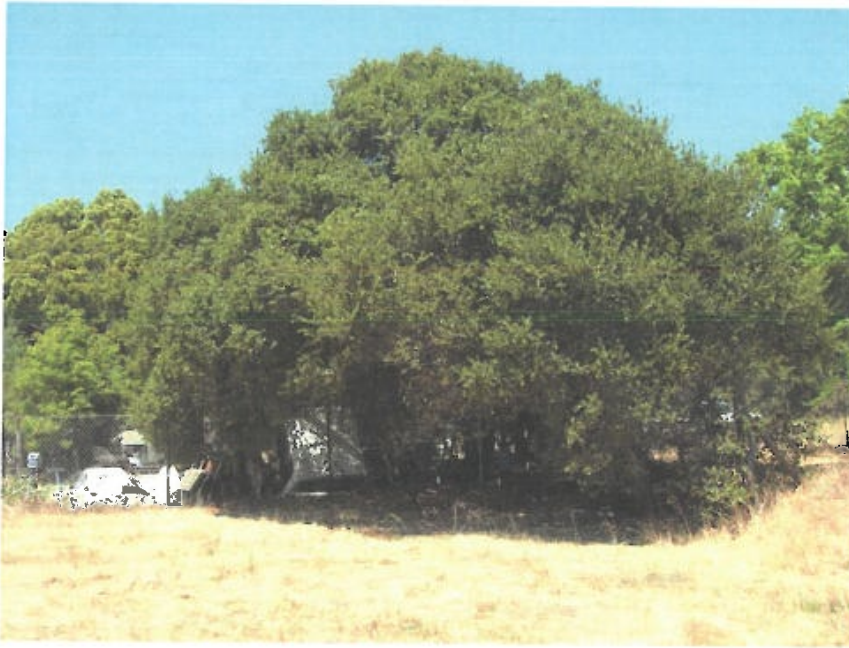
Tree #52 - 15-inch DBH Coast Live Oak:

Tree #53 - 13 & 14-inch DBH Coast Live Oak:

These two oaks are located to the southwest of the house at 1500 Capitola road. The two oaks are worthy of preservation based upon their condition ratings, however it appears that they will be situated within the construction footprint as shown on the conceptual site plan provided to me.

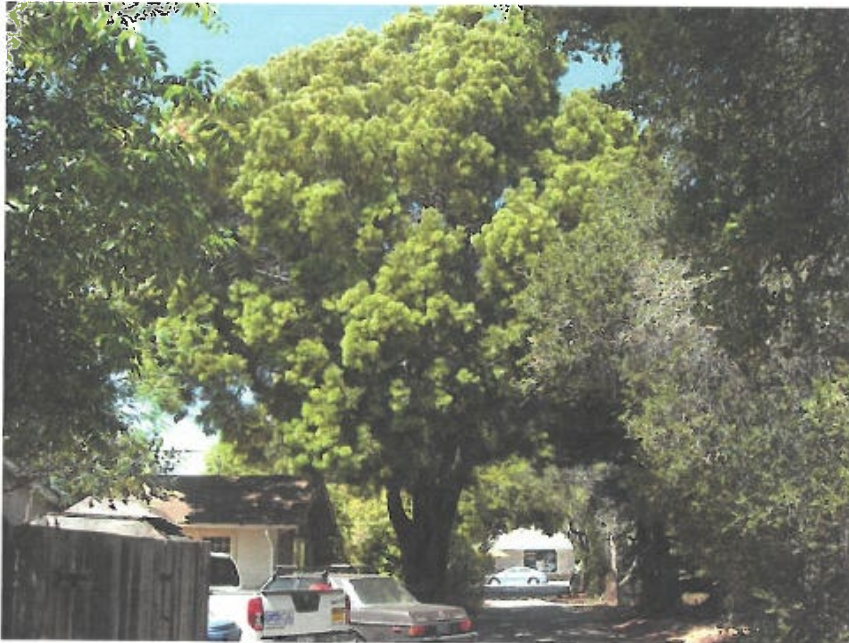
This large tree is located east of the residence at 1438 Capitola Road. I noted that it has a co-dominant structure having two scaffold trunks attached to a common trunk. The area of attachment between the two scaffold trunks is poor. The tree is recommended for preservation based upon its overall condition rating. I noted that this tree is located within the proposed construction footprint, as shown on the conceptual schematic provided to me.

In the event that it can be preserved, it must be pruned to improve its structure and support cables must be installed between the scaffold limb structure to improve its structural integrity.

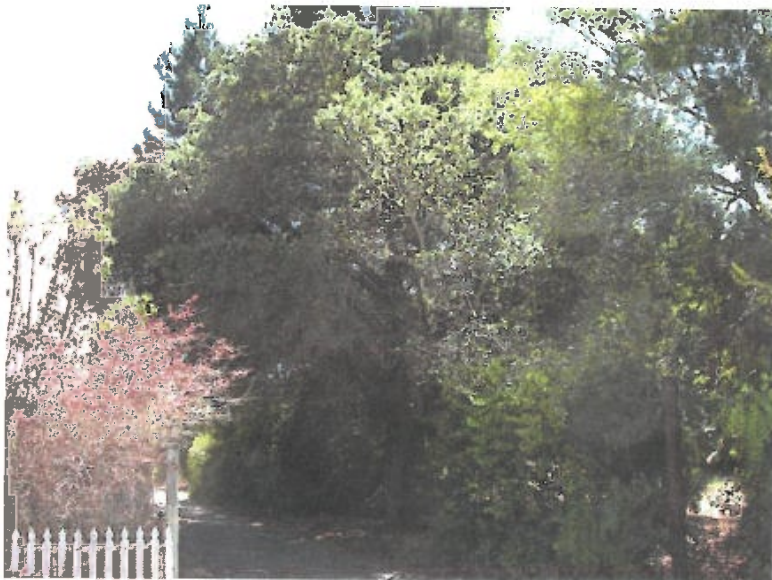
Tree #66 - 22-inch DBH Coast Live Oak:

This oak, exhibits good health and it has a fair structural condition. It is worthy of preservation if there will be adequate space for the protection of its Critical Root Zone Area during the design and construction phases of this project. I also recommend that this tree is pruned to improve its structural condition, if preserved.

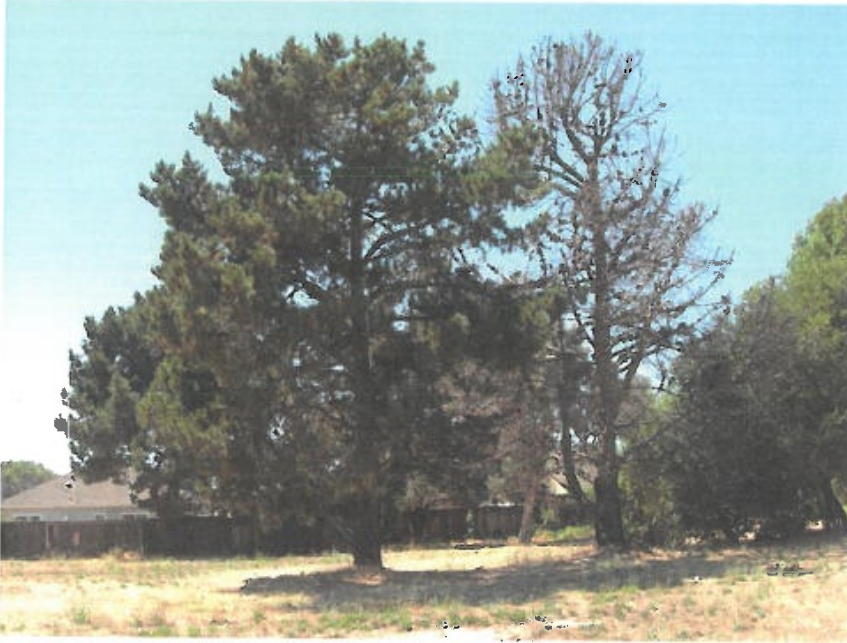
Tree #82 - 22-inch DBH Monterey Pine (*Pinus radiata*):

This pine has died as a result of the recent drought period and a resultant infestation by Red Turpentine Beetle (*Dendroctonus valens*) and Engraver Beetles (*Ips spp.*).

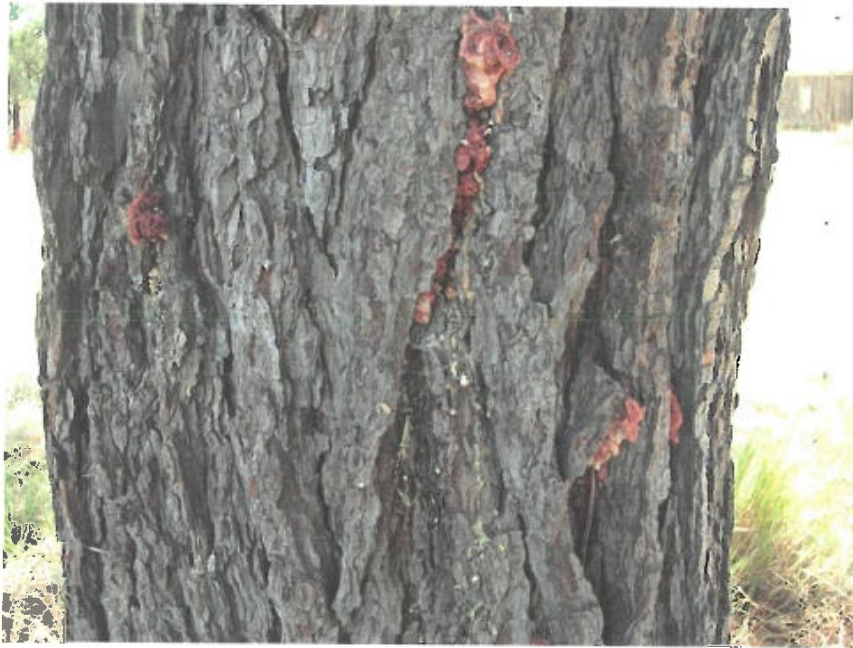
Tree #83 - 22-inch DBH Monterey Pine:

This pine is recommended for removal based upon its condition rating and location.

I noted that this pine has a significant infestation of Red Turpentine Beetle on its lower trunk. The tree is located within the footprint of the housing development as shown on the conceptual schematic provided to me.

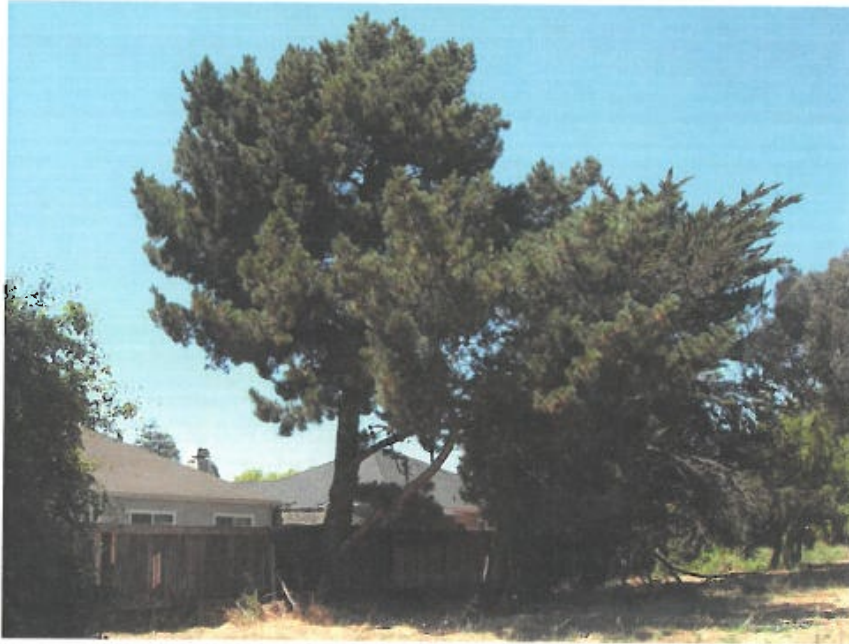
Tree #116 - 29-inch DBH Monterey Pine:

This mature pine is located next to the western boundary. I noted a number of distinctive pitch tubes on the lower trunk associated with an infestation by Red Turpentine Beetle.

The tree is suitable for preservation based upon its condition rating, however I recommend that it is considered for removal because of its close proximity to the proposed parking area as represented on the conceptual site plan provided to me. The construction of the parking area as shown will likely result in significant root loss within the Critical Root Zone Area of this mature pine.

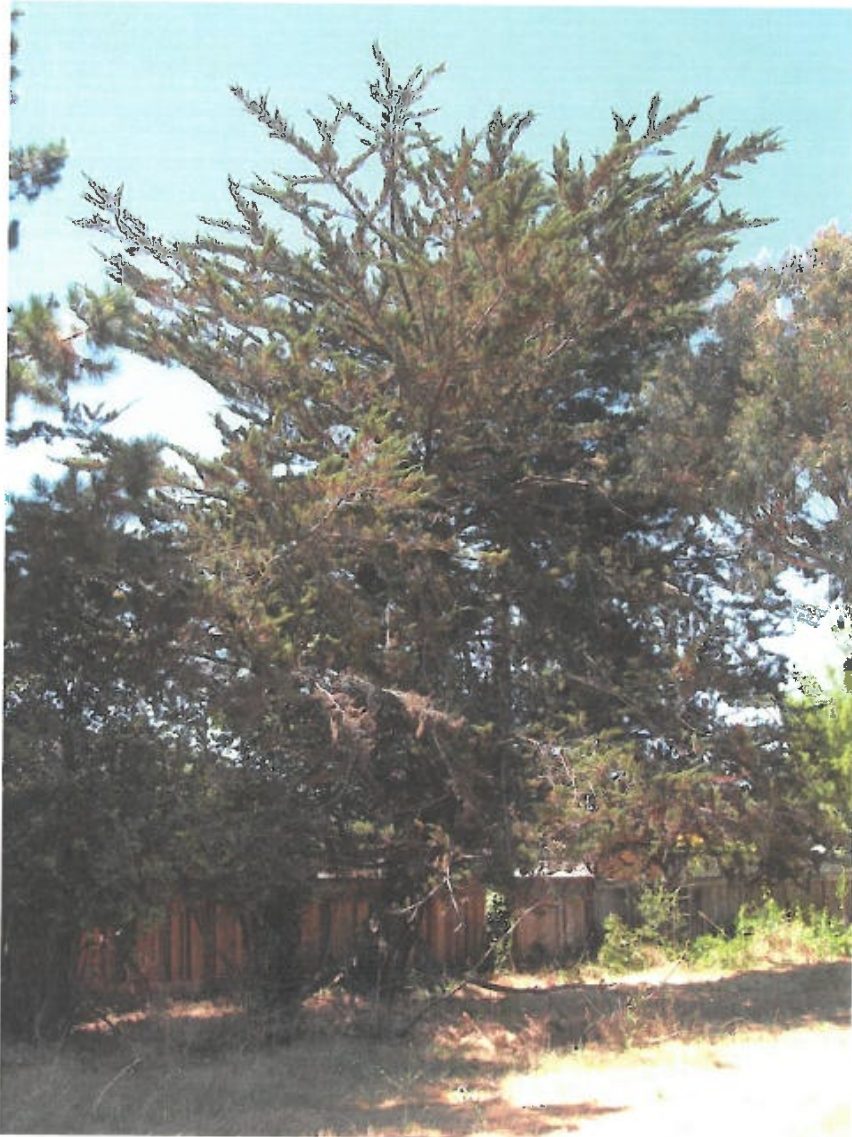
Tree #118 - 30-inch DBH Monterey Cypress (*Hesperocyparis macrocarpa*):

This large tree is located on the west boundary of the project site. It must be removed as it has partially failed in the ground as evidenced by its strong lean to the east and the heaved soil area observed on the west side of the trunk. The tree also exhibits fair to poor health at this time.

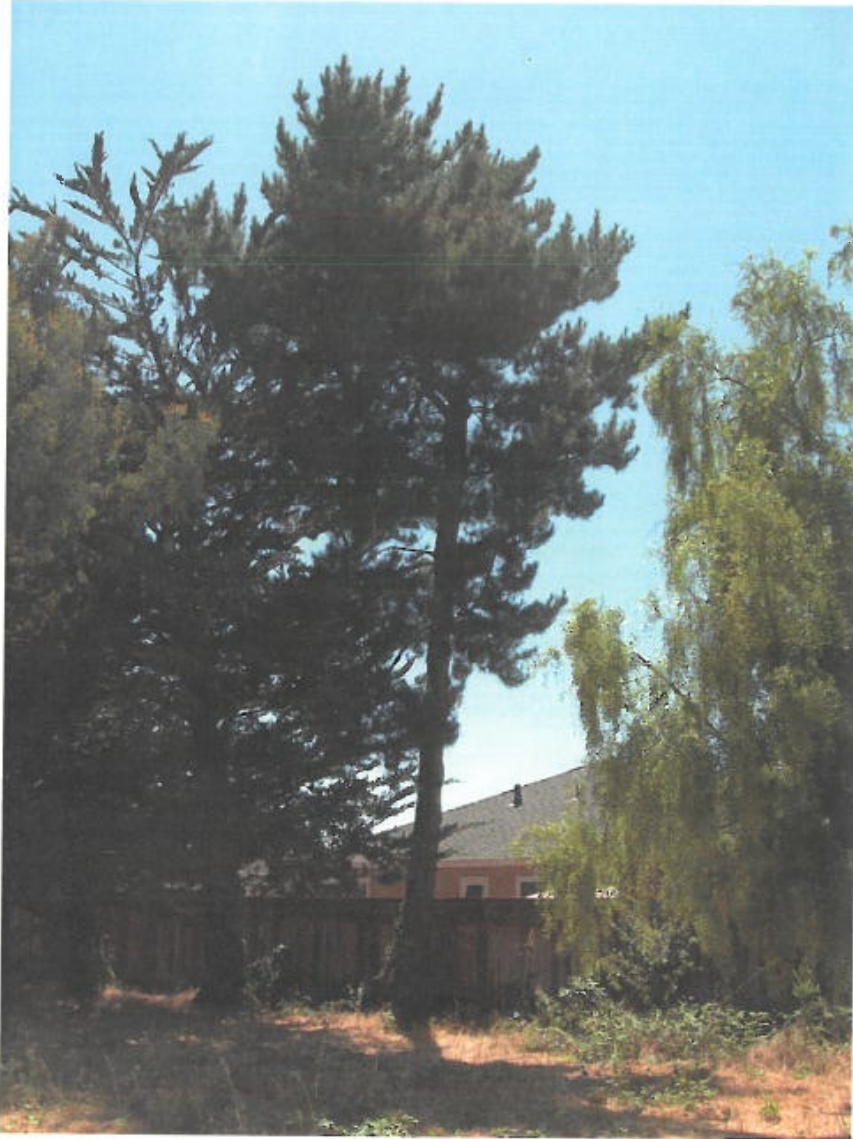
Tree #120 - 22-inch DBH Monterey Pine:

This mature pine is situated next to the western property boundary. The tree exhibits good health and has a poor structural condition rating. The top of this tree has developed a heavy lean and I noted that the great majority of the limb structure had been removed over the neighbor's yard.

I recommend that this tree is removed because of its close proximity poor structure and its location next to the proposed parking area as represented on the conceptual schematic provided to me. The construction of the parking area as shown, will likely result in significant root loss within the Critical Root Zone Area of this mature pine.

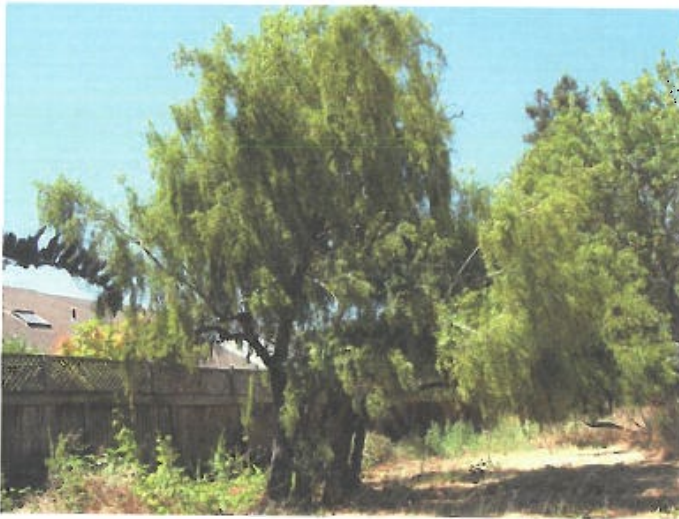
Tree's #121 through #123 - Three Mayten Trees:

These three trees are growing within close proximity to each other and they have fair overall condition ratings. I recommend that these crowded trees are removed and replaced with a more desirable species.

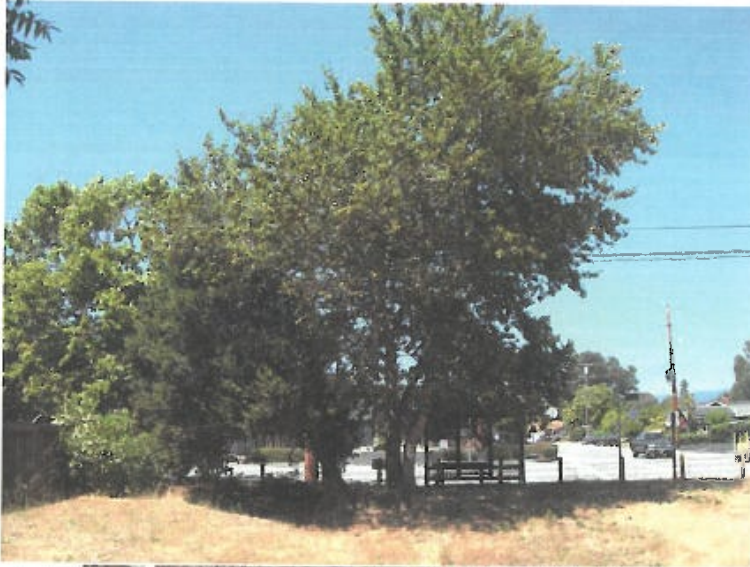
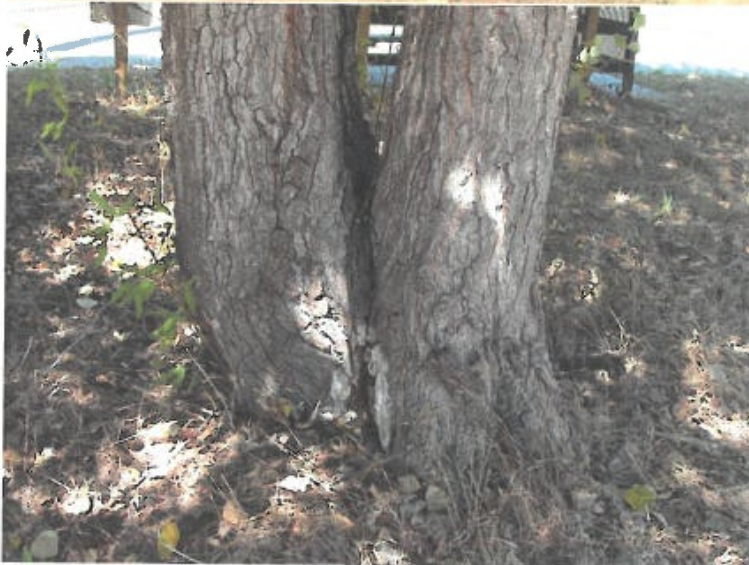
Tree #134 - 12 & 15-inch DBH Cottonwood Poplar (*Populus spp.*):

I recommend that this tree is removed because of its poor condition rating and its undesirable species characteristics. This species is not recommended for preservation as a landscape tree because of its weak growth pattern and invasive root growth habit.

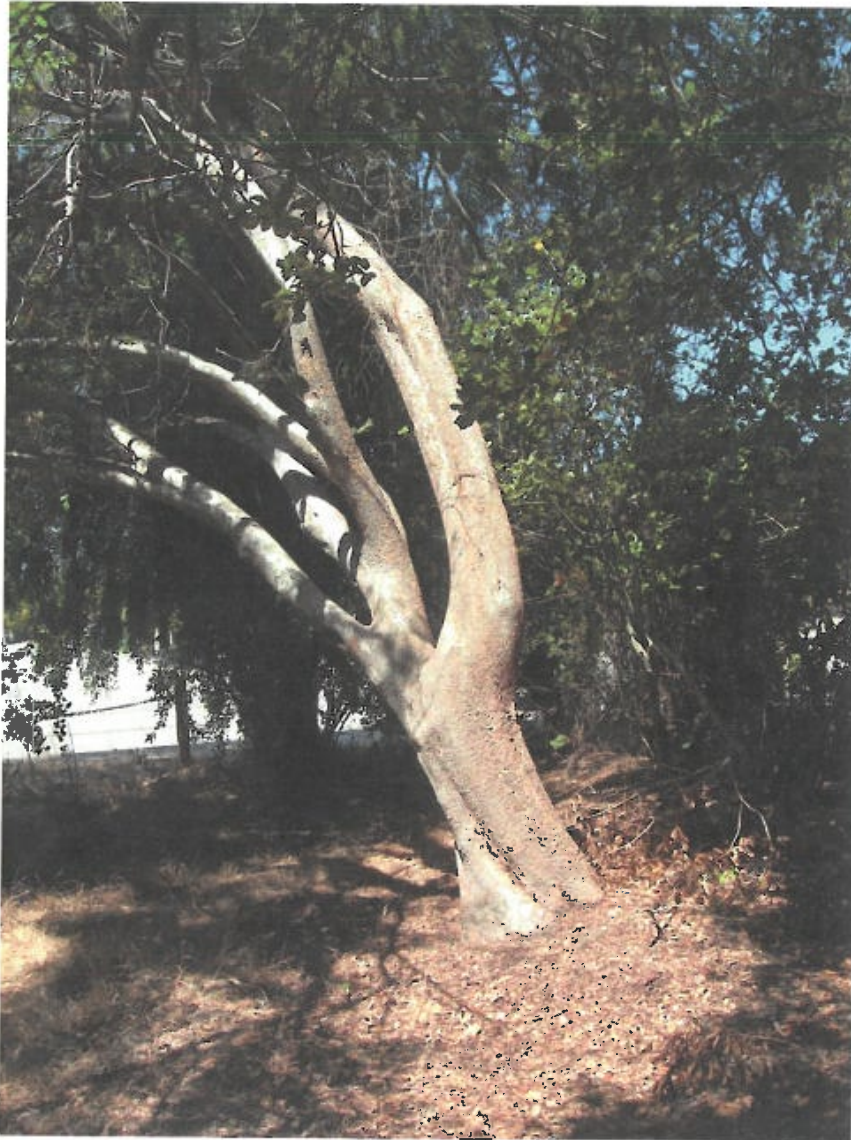
Tree #137 - 19-inch DBH Chinese Elm (*Ulmus parvifolia*):

This Elm has a very poor structure, having developed an asymmetrical growth pattern and heavy scaffold limb development on one side. I recommend that this tree is removed because it is vulnerable to failure at this time.

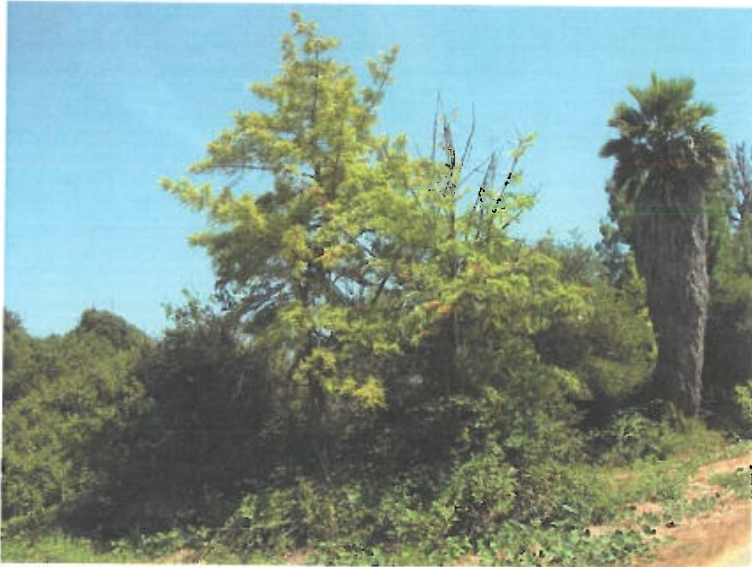
Tree's #144 & #146 - Two Silk Oaks (*Grevillea robusta*):

These trees are not worthy of preservation due to their poor condition ratings and appearance.

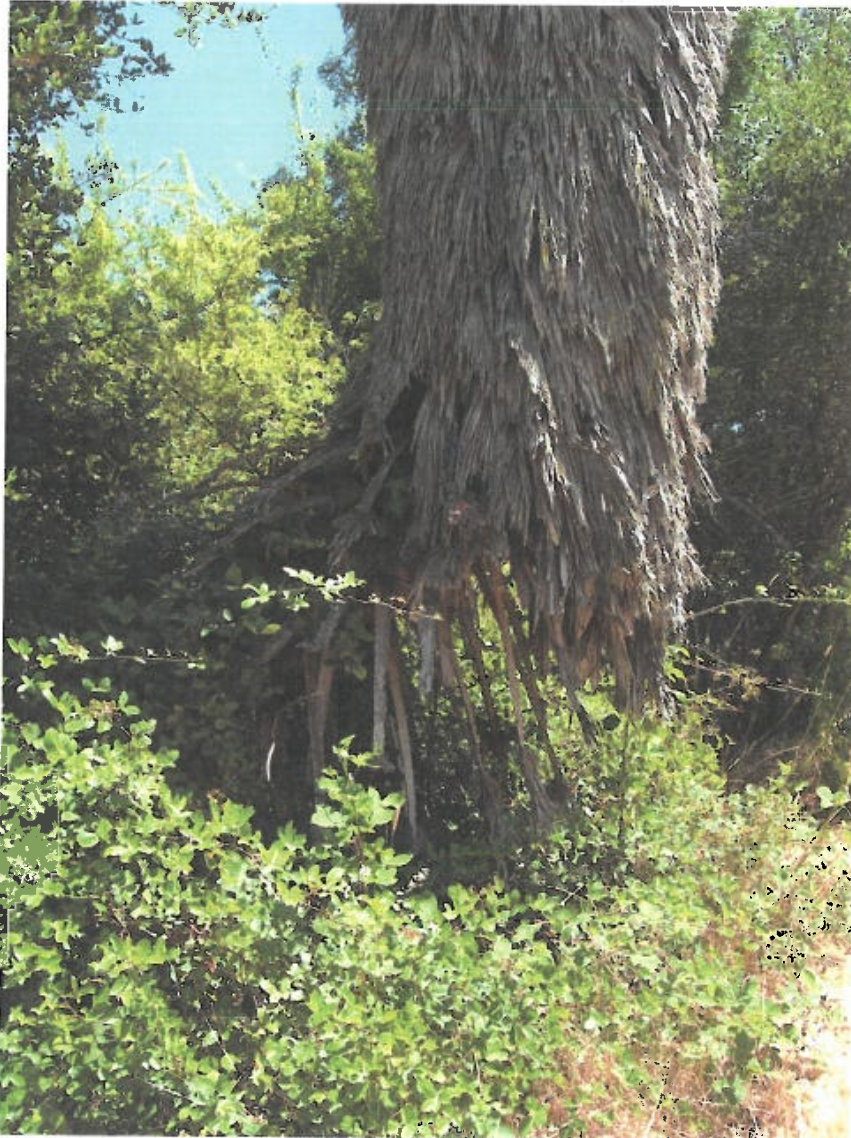
This established palm is recommended for removal due to its poor growth pattern. The lower trunk has developed a large bow to the west, which is a significant structural defect.
