Nigel Belton

Consulting Arborist

**AN ASSESSMENT OF THE TREES LOCATED WITHIN THE PROPOSED DEVELOPMENT SITE
AT 1412, 1438, 1500 AND 1514 CAPITOLA ROAD, SANTA CRUZ - CALIFORNIA**

Site visit by:
Nigel Belton - ISA Certified Arborist WE-0410A
July 16, 2018

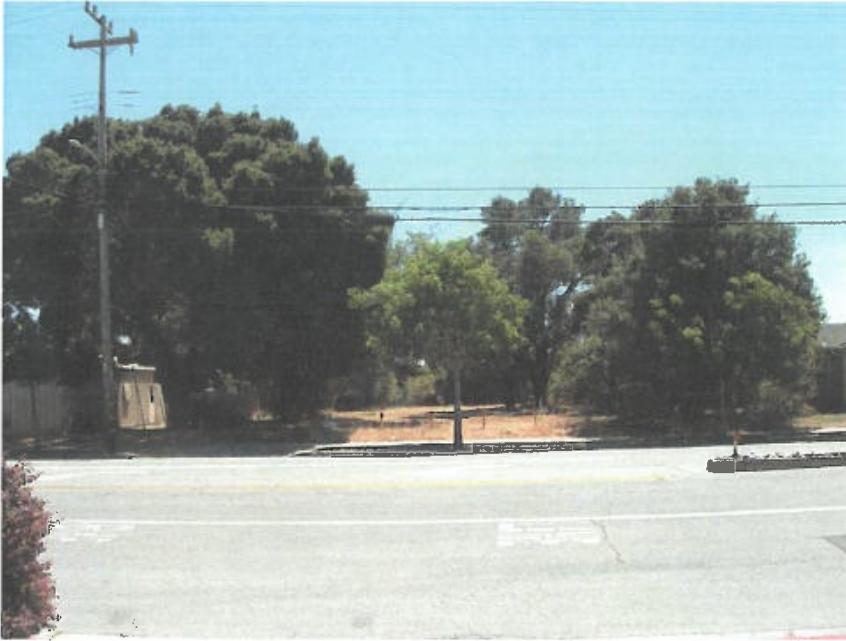
Tree #5- 14-inch DBH Coast Live Oak:

These three oaks are located in the northeast corner of the project site and are recommended for preservation and protection due to their good condition ratings. I recommend that these oaks are pruned to improve their structural conditions and appearance.

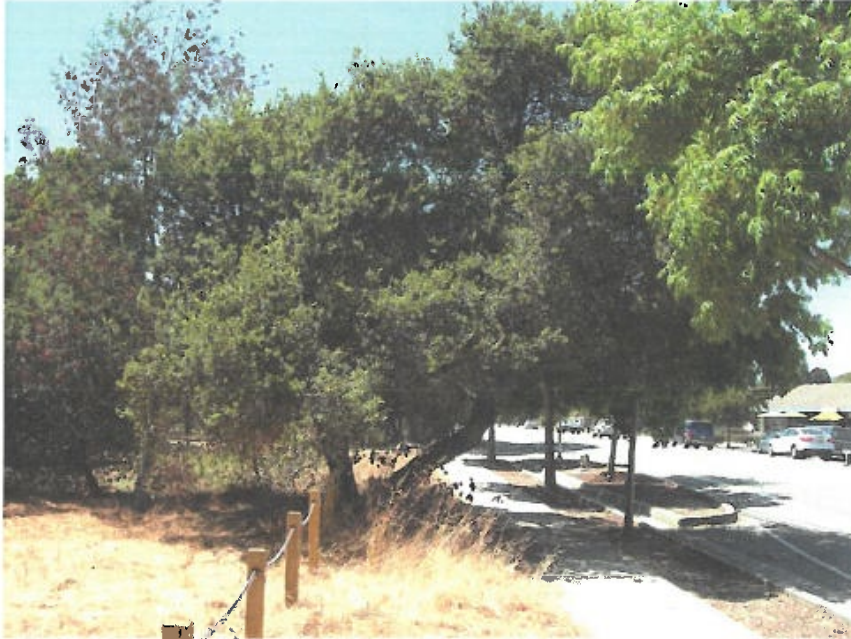
Tree #34- 14 7 13-inch DBH Coast Live Oak:

This oak is located next to the sidewalk at the front of 1514 Capitola Road. I noted that it will likely be situated within the entry way to the proposed parking area.

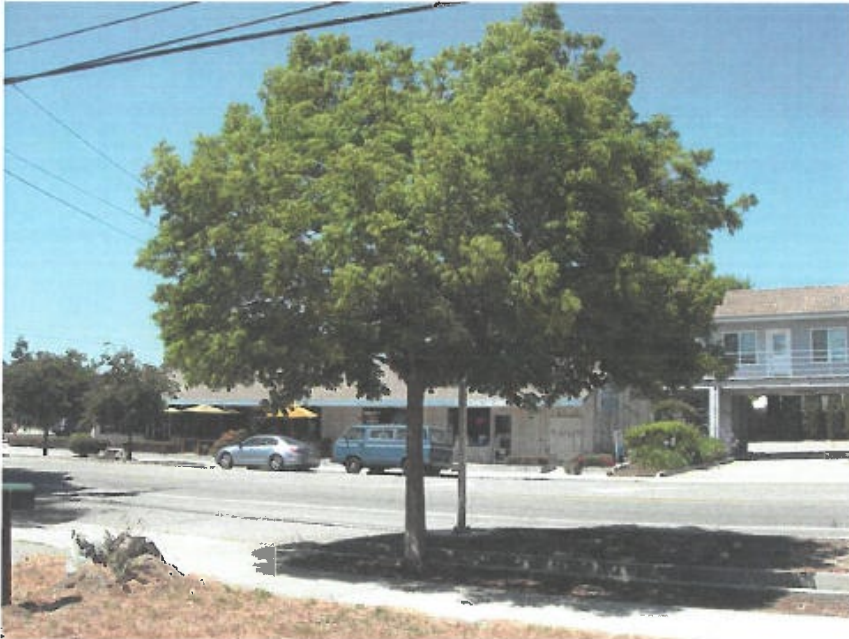
Tree's #35, #36, #37 and #152 - Four Chinese Pistache (*Pistacia chinensis*):

The four Chinese Pistache growing in the landscape strip between the sidewalk and the curb are attractive trees that exhibit good health and generally have good structural conditions. They are recommended for protection during the design and construction of this project, if at all possible.

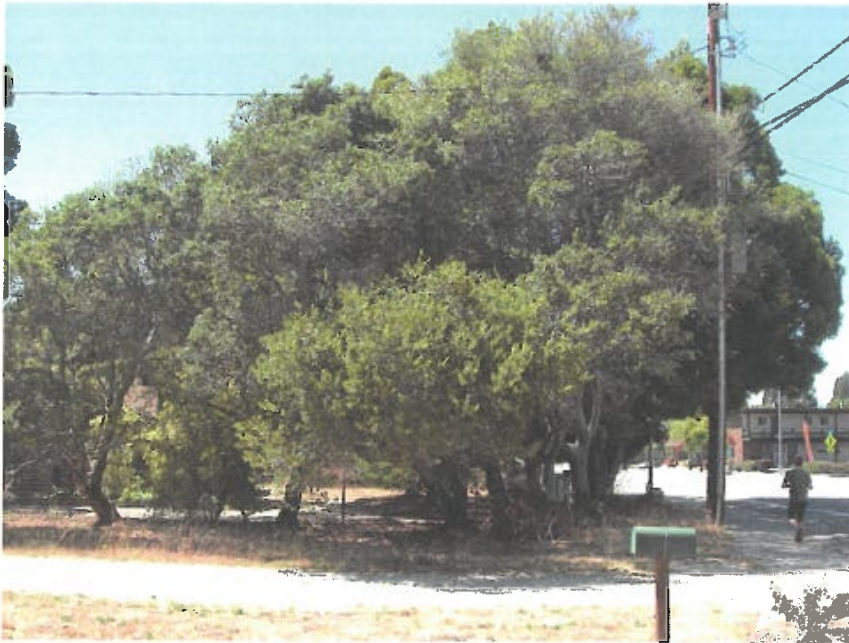
This cluster of five Coast Live Oaks is located near the road frontage to the northwest of the residence at 1500 Capitola Road. All of these trees are worthy of preservation and protection during the design and construction phases of this project, if space permits.

I recommend that the oaks are pruned to improve their structures and appearance. Remove larger dead wood and reduce end-weight on any heavy and overextended limbs.

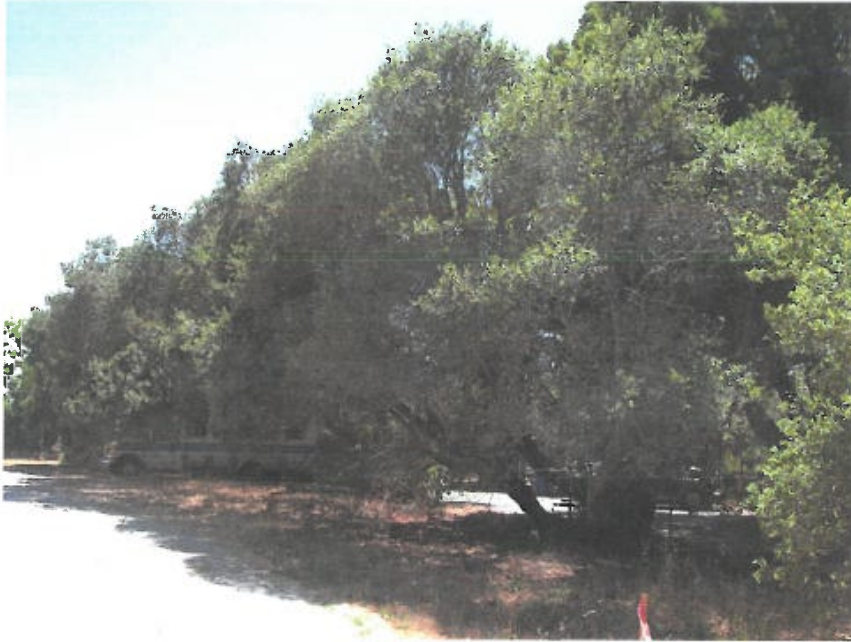
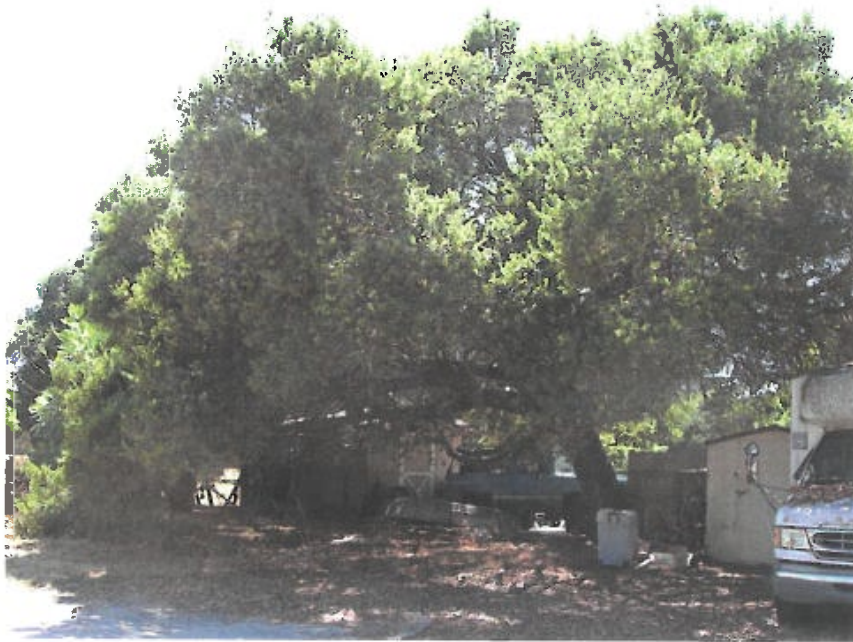
Tree #50 - 10-inch DBH Coast Live Oak:

These three oaks are located on the property boundary to the southwest of the house at 1500 Capitola Road. All three oaks are worthy of preservation based upon their condition ratings, however it appears that they will be situated within the construction footprint, as shown on the conceptual schematic provided to me.

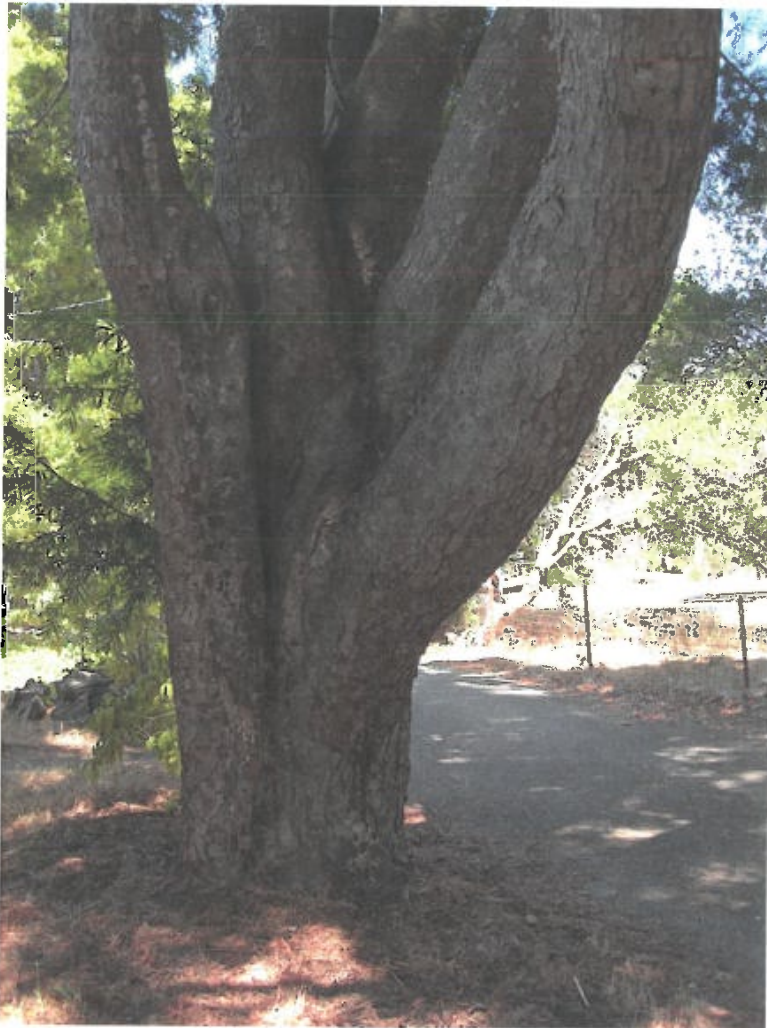
This large tree is located east of the residence at 1438 Capitola Road. I noted that it has a co-dominant structure having two scaffold trunks attached to a common trunk. The area of attachment between the two scaffold trunks is poor. The tree is recommended for preservation based upon its overall condition rating. I noted that this tree is located within the proposed construction footprint, as shown on the conceptual schematic provided to me.

In the event that it can be preserved, it must be pruned to improve its structure and support cables must be installed between the scaffold limb structure to improve its structural integrity.

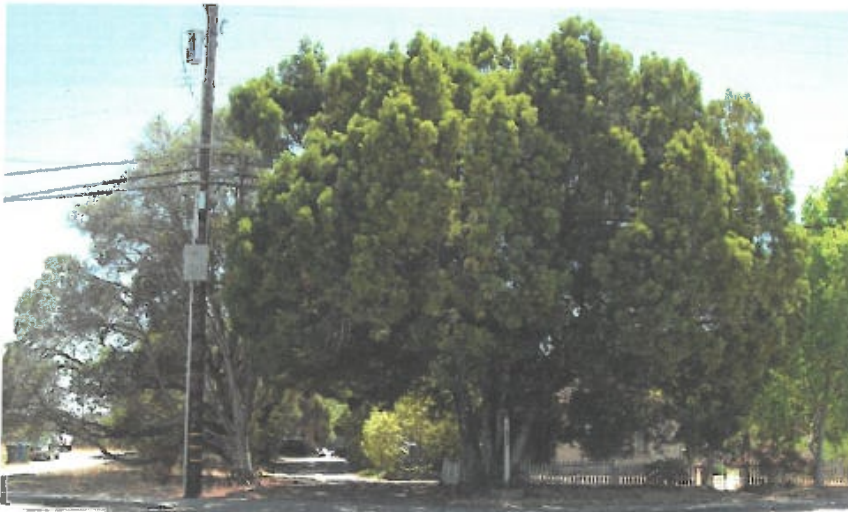
This large tree is growing within the street frontage next to Capitola Road. The tree exhibits good health but it has a poor structural condition due to the development of multiple scaffold limbs attached at the common trunk.

The tree is recommended for preservation based upon its condition rating and as long enough of the root zone can be preserved during construction. In the event that this tree can be preserved, it must be protected and pruned to improve its structure. Support cables must also be installed between the scaffold limb structure in order to improve its structural integrity.

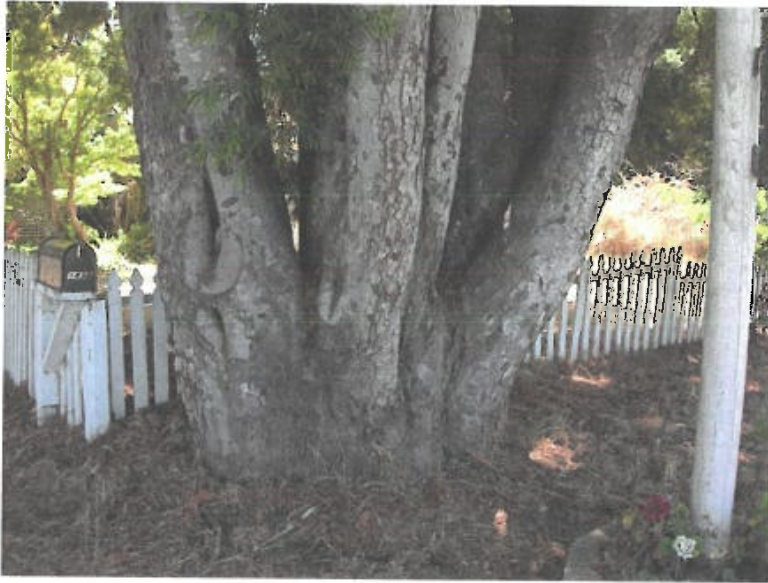
Tree #66 - 22-inch DBH Coast Live Oak:

This oak, exhibits good health and it has a fair structural condition. It is worthy of preservation if there will be adequate space for the protection of its Critical Root Zone Area during the design and construction phases of this project. I also recommend that this tree is pruned to improve its structural condition, if preserved.

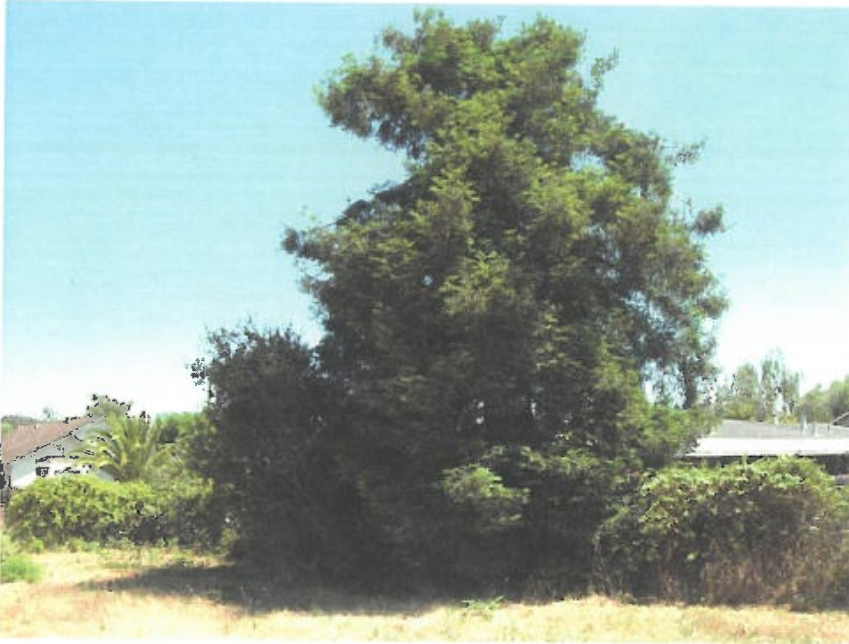
The trunk of this healthy redwood is primarily located on the adjacent private property to the south of 1438 Capitola Road. The trunk appears to transect the property boundary.

The tree is worthy of preservation and its Critical Root zone must be protected during the construction period. I recommend that construction disturbances are limited to the edge of the canopy drip-line if at all possible. The small Coast Live Oak next to it should be removed.

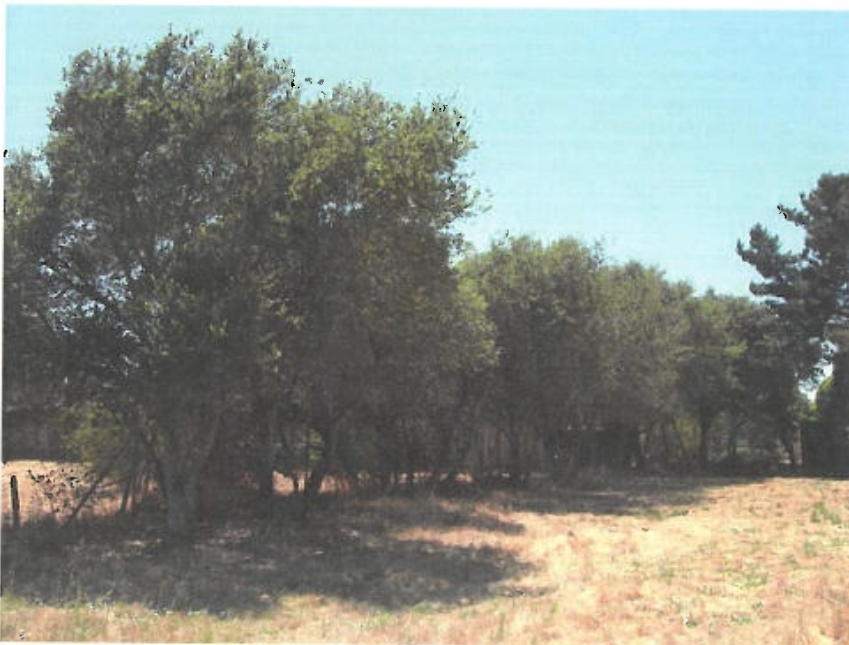
The row 22 Coast Live Oaks growing within the proximity of the southwest corner of the project site are young trees which exhibit good health. These trees provide valuable screening along the project boundary and are recommended for preservation and protection during the construction phase. The preservation of these oaks will require that there is an adequate setback distance between their trunks and the new curb line of the proposed parking area, as shown on the conceptual site plan (preferably a minimum eight-foot setback distance between the trunks and the curb line if possible).

A number of these trees are crowded close together and some of the poorer specimens could be removed to provide for more space between them.

The three Arizona Cypress Trees (*Hesperocyparis arizonica*) and the one Mayten Tree (*Maytenus boaria*) growing within this row of oaks should be removed because of their poor condition ratings.

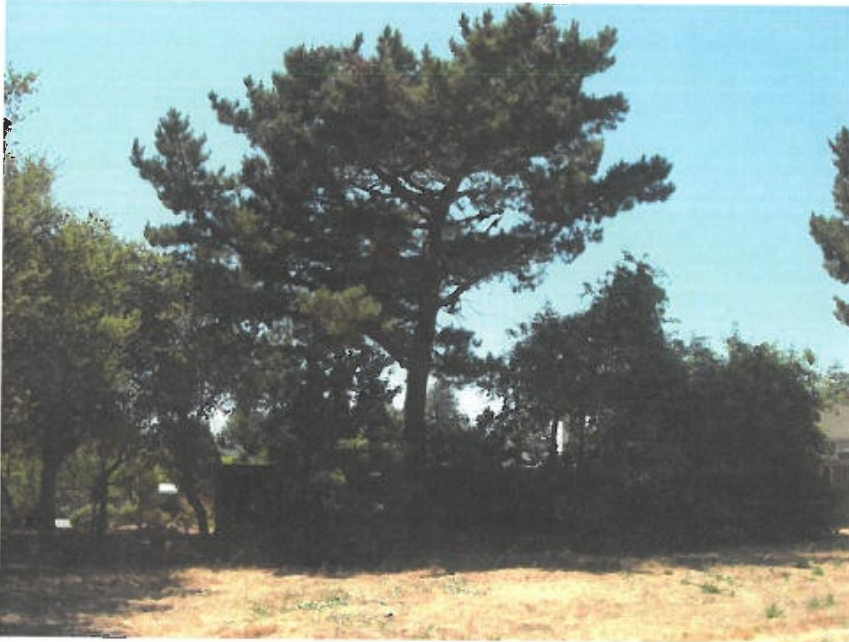
Tree #114 - 22-inch DBH Monterey Pine:

This mature pine is located on the west boundary of the project site. It is recommended for removal due to its poor condition rating and its close proximity to proposed construction disturbances. I noted that the top of the pine had been previously killed by Pine Pitch Canker (*Fusarium circinatum*) and that the loss of apical dominance resulted in the development of a heavy limb structure which is vulnerable to failure. I also noted a number of active Pine Pitch Canker infection sites in some of the limb ends.

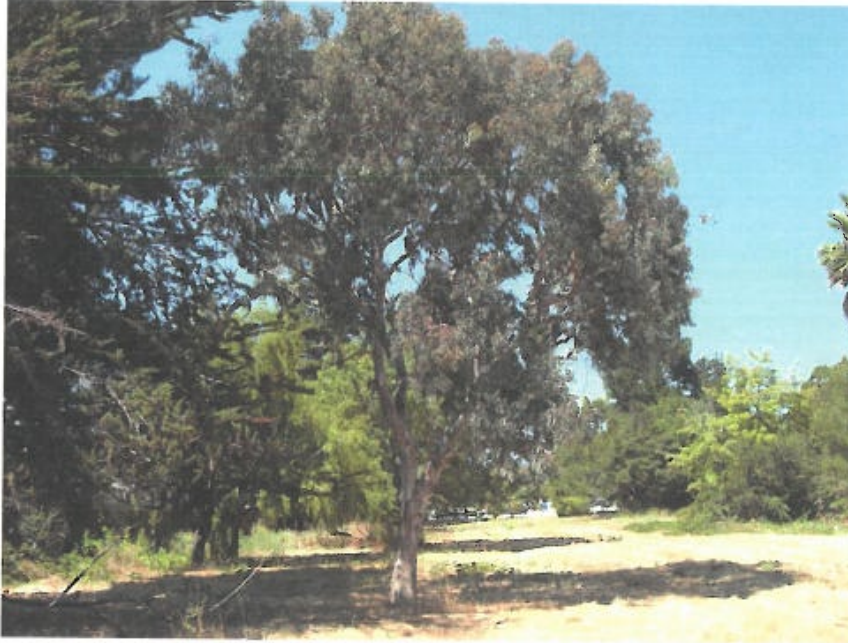
Tree #119 - 18-inch Eucalyptus Tree (*Eucalyptus spp.*):

This tree exhibits good health and has a good structural condition which makes it worthy of preservation. Unfortunately, it appears to be located within the development footprint.

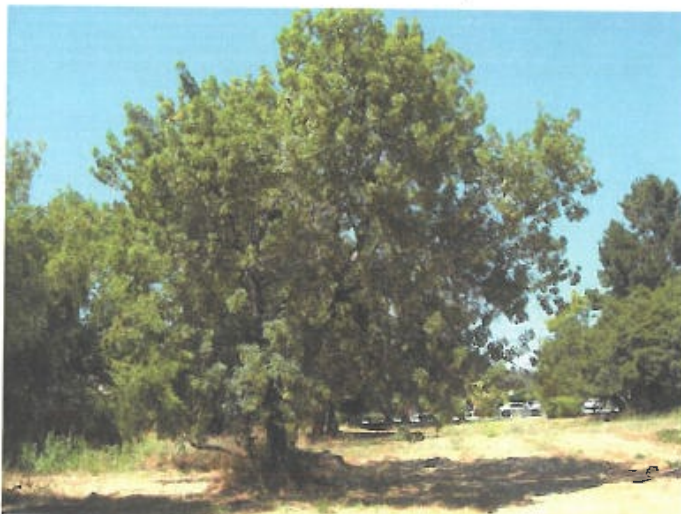
This tree is worthy of preservation based upon its condition rating.

In the event that it can be preserved and will be setback far enough from construction disturbances, it must be pruned to improve its structural condition and appearance.

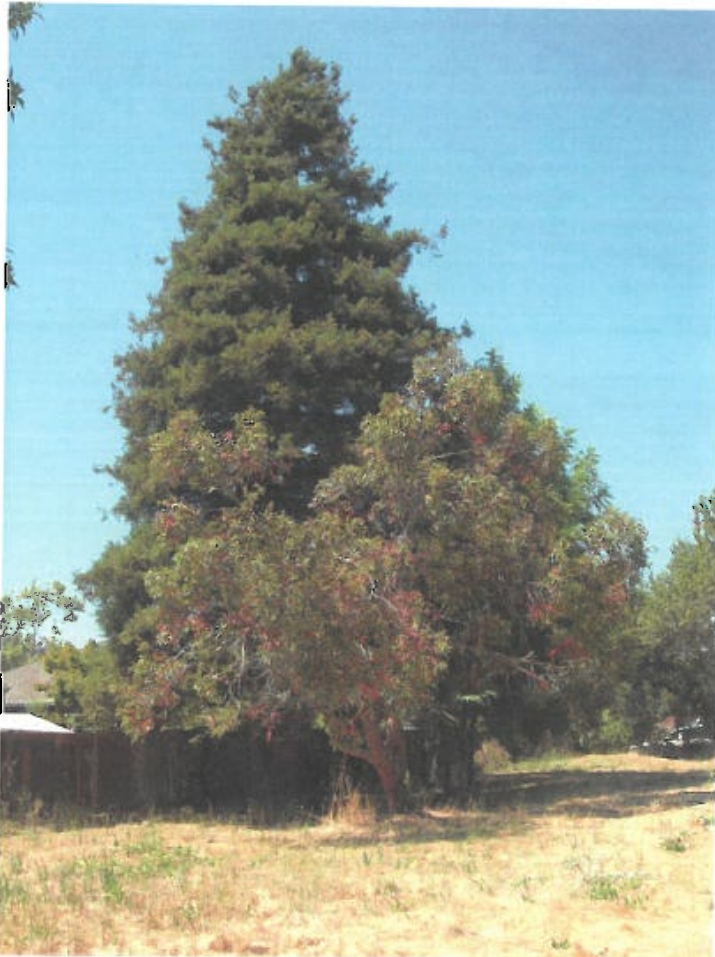
This large tree is located near the western boundary of the project site and it is worthy of preservation and protection during the design and construction phases of the development.

I noted that the conceptual site plan shows the proposed landscape area around this tree to be large enough in size to ensure the preservation of its Critical Root Zone Area.

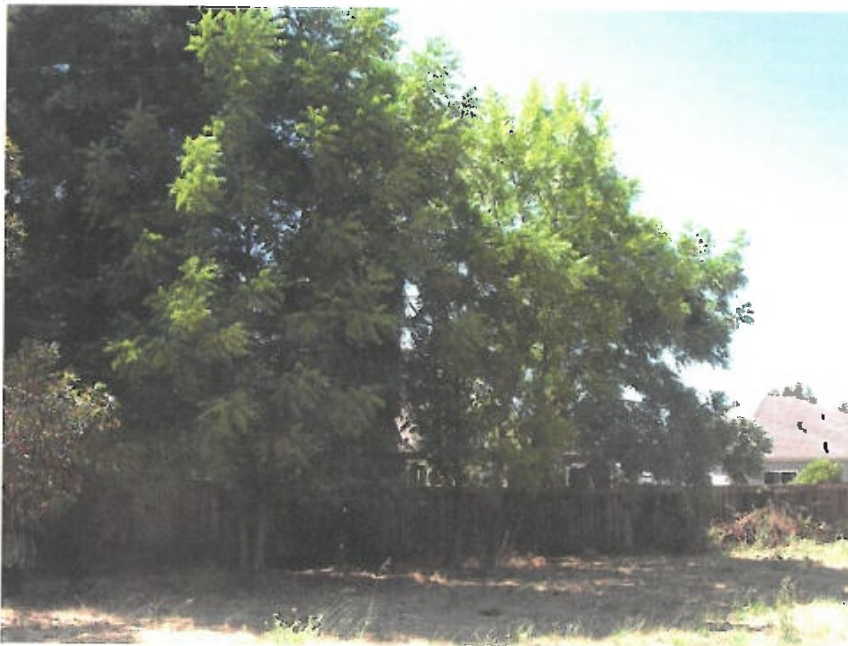
Tree's #131 through #133 - Three 6-inch, 6-inch & 8-inch DBH Black Walnuts:

These three trees are recommended for preservation because of their good overall condition ratings. I noted that the surrounding landscape area represented on the conceptual site plan appears to be large enough for the preservation of these trees. I recommend that they are pruned to improve their structures.

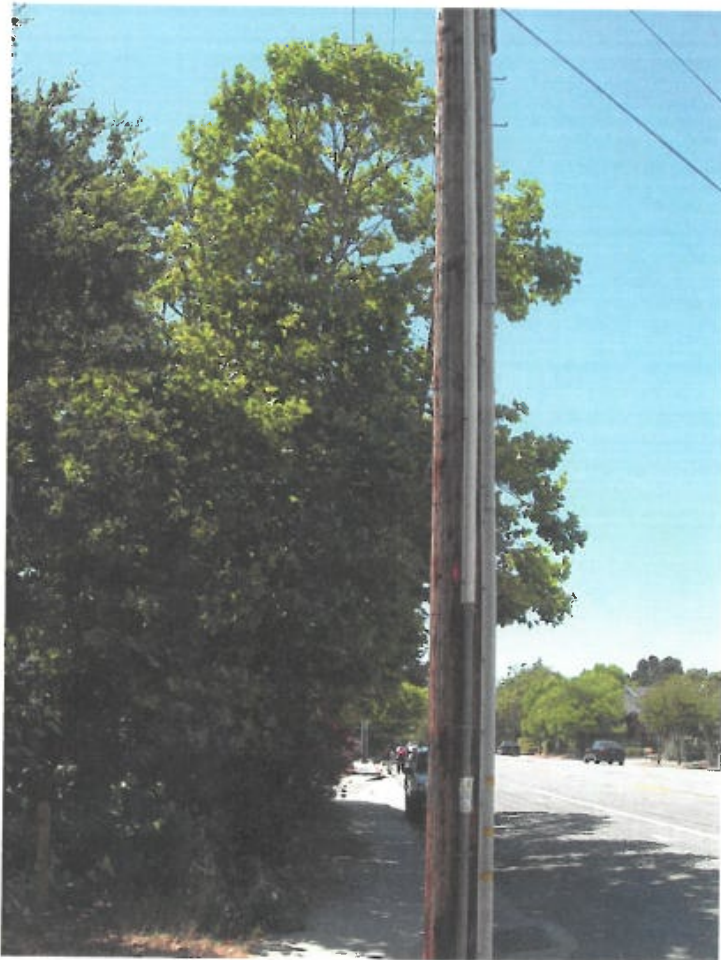
Tree #136 - 11-inch DBH London Plane Sycamore (*Platanus x hispanica*):

This tree is located in the landscape in front of the adjacent property to the left of the project site. It has been included within this report because its Critical Root Zone must be protected during the construction period.

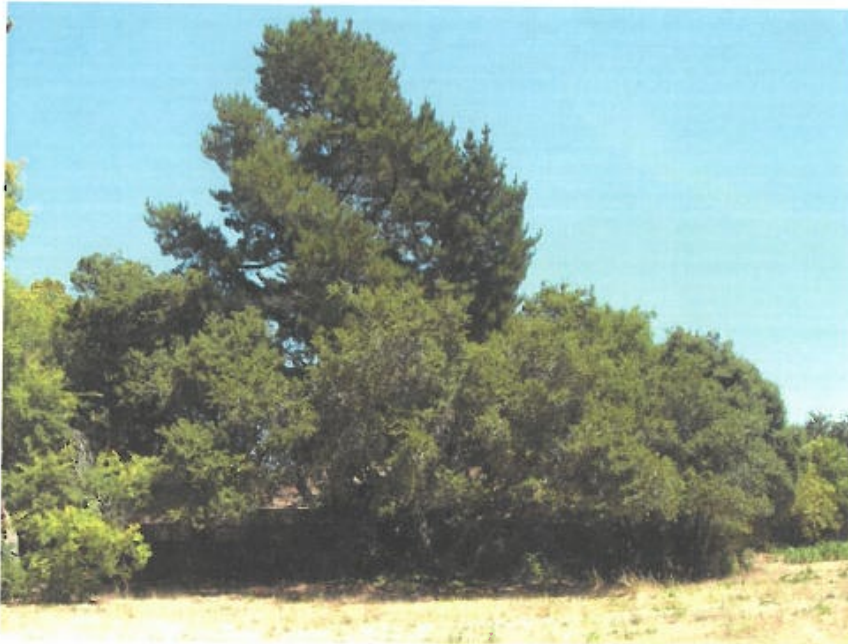
Tree's #139 through #142 - Four Coast Live Oaks:

These four trees have DBH measurements equaling 13 & 16, 3 & 4, 13 and 7 & 9-inches, respectively. All of these trees are worthy of preservation based upon their condition ratings.

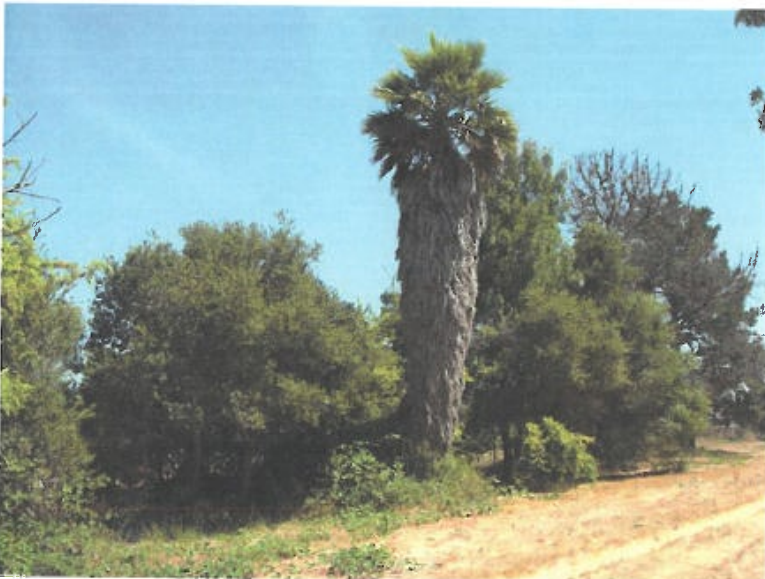
Tree's #147 through #149 - Three small Coast Live Oaks:

These young oaks have trunk diameters of less than 10-inches at 54-inches above grade. They are worthy of preservation, as long as a large enough area of landscape will be available for the protection of their rootzones.
