**Former Live Oak Service Station
1671 Capitola Rd.
Santa Cruz, California**

**March 27, 2012
PCE Isoconcentration Map**

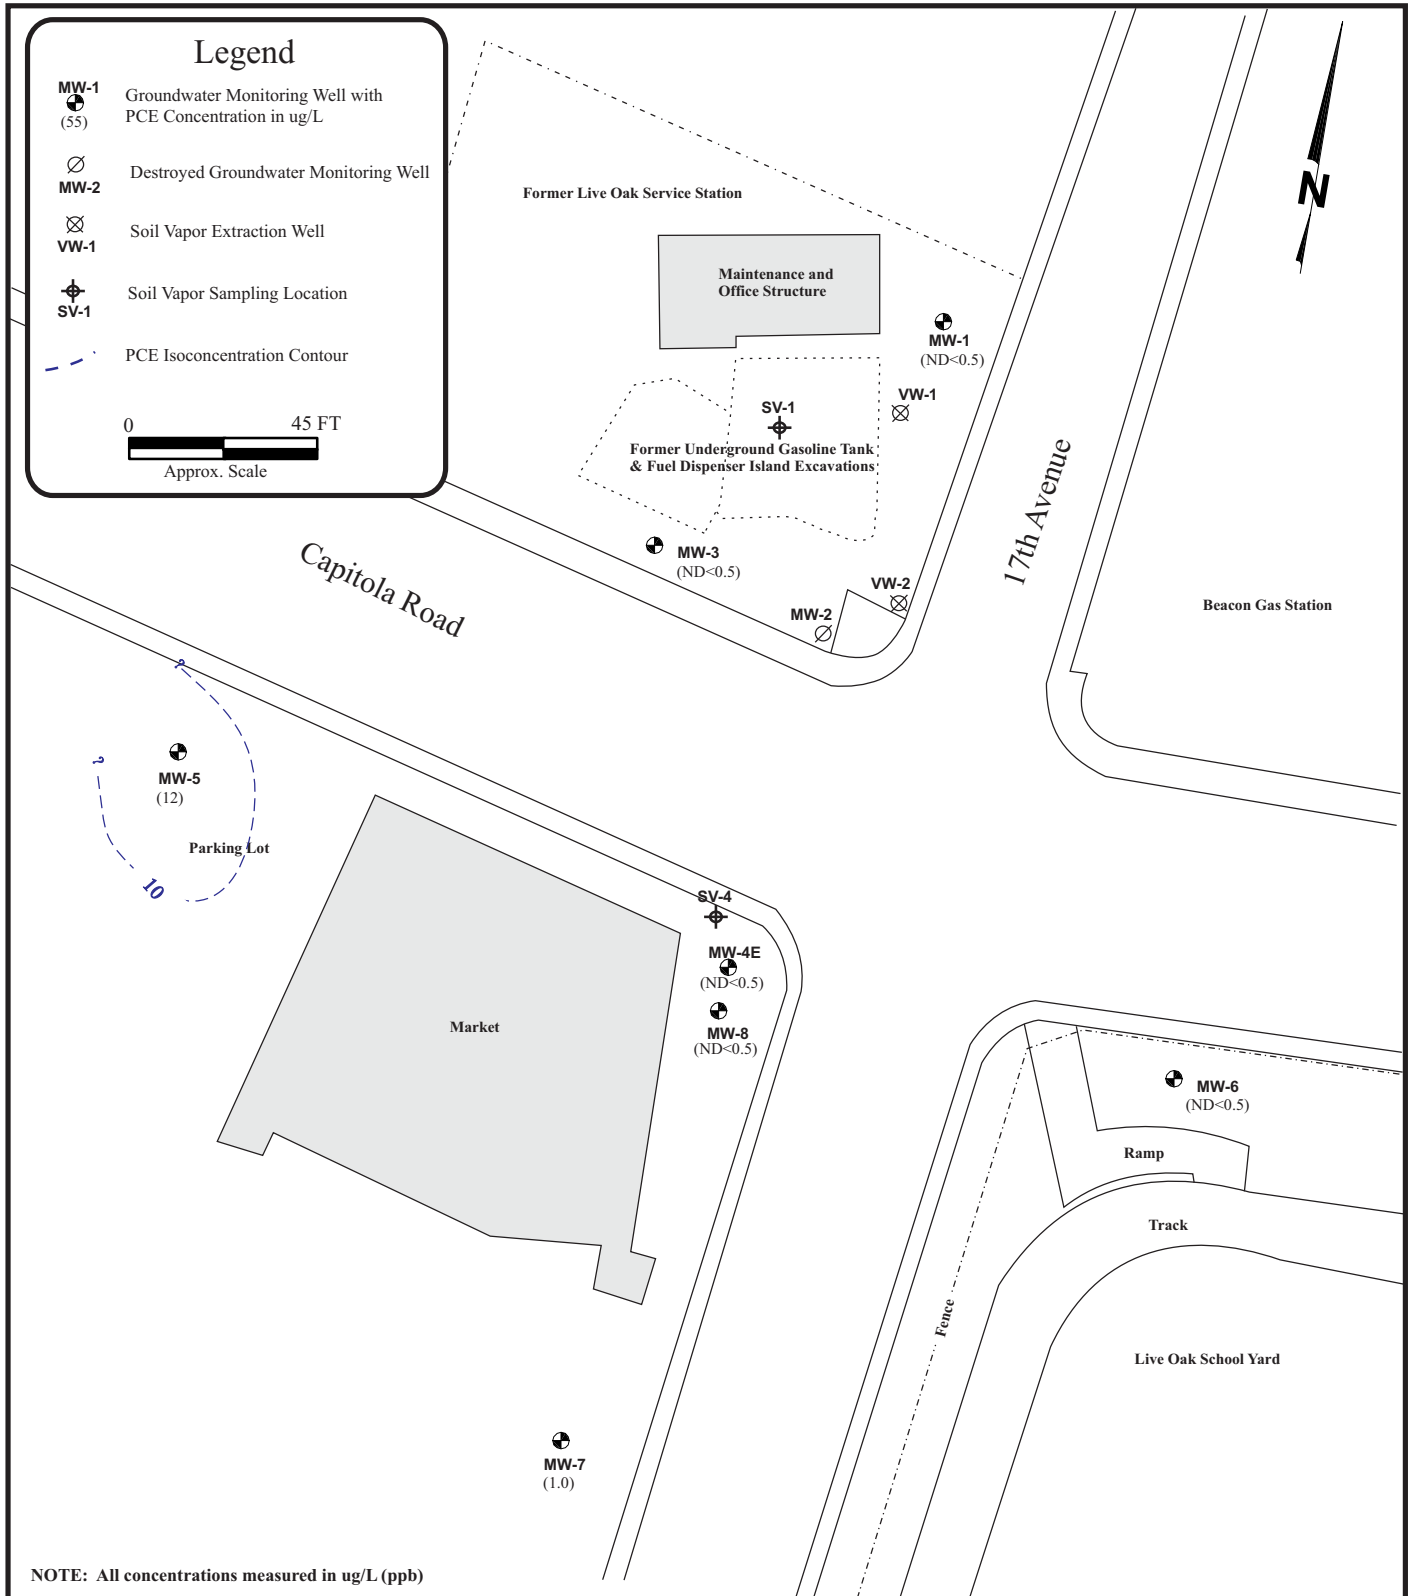
5B

**December 10, 2010
PCE Isoconcentration Map**

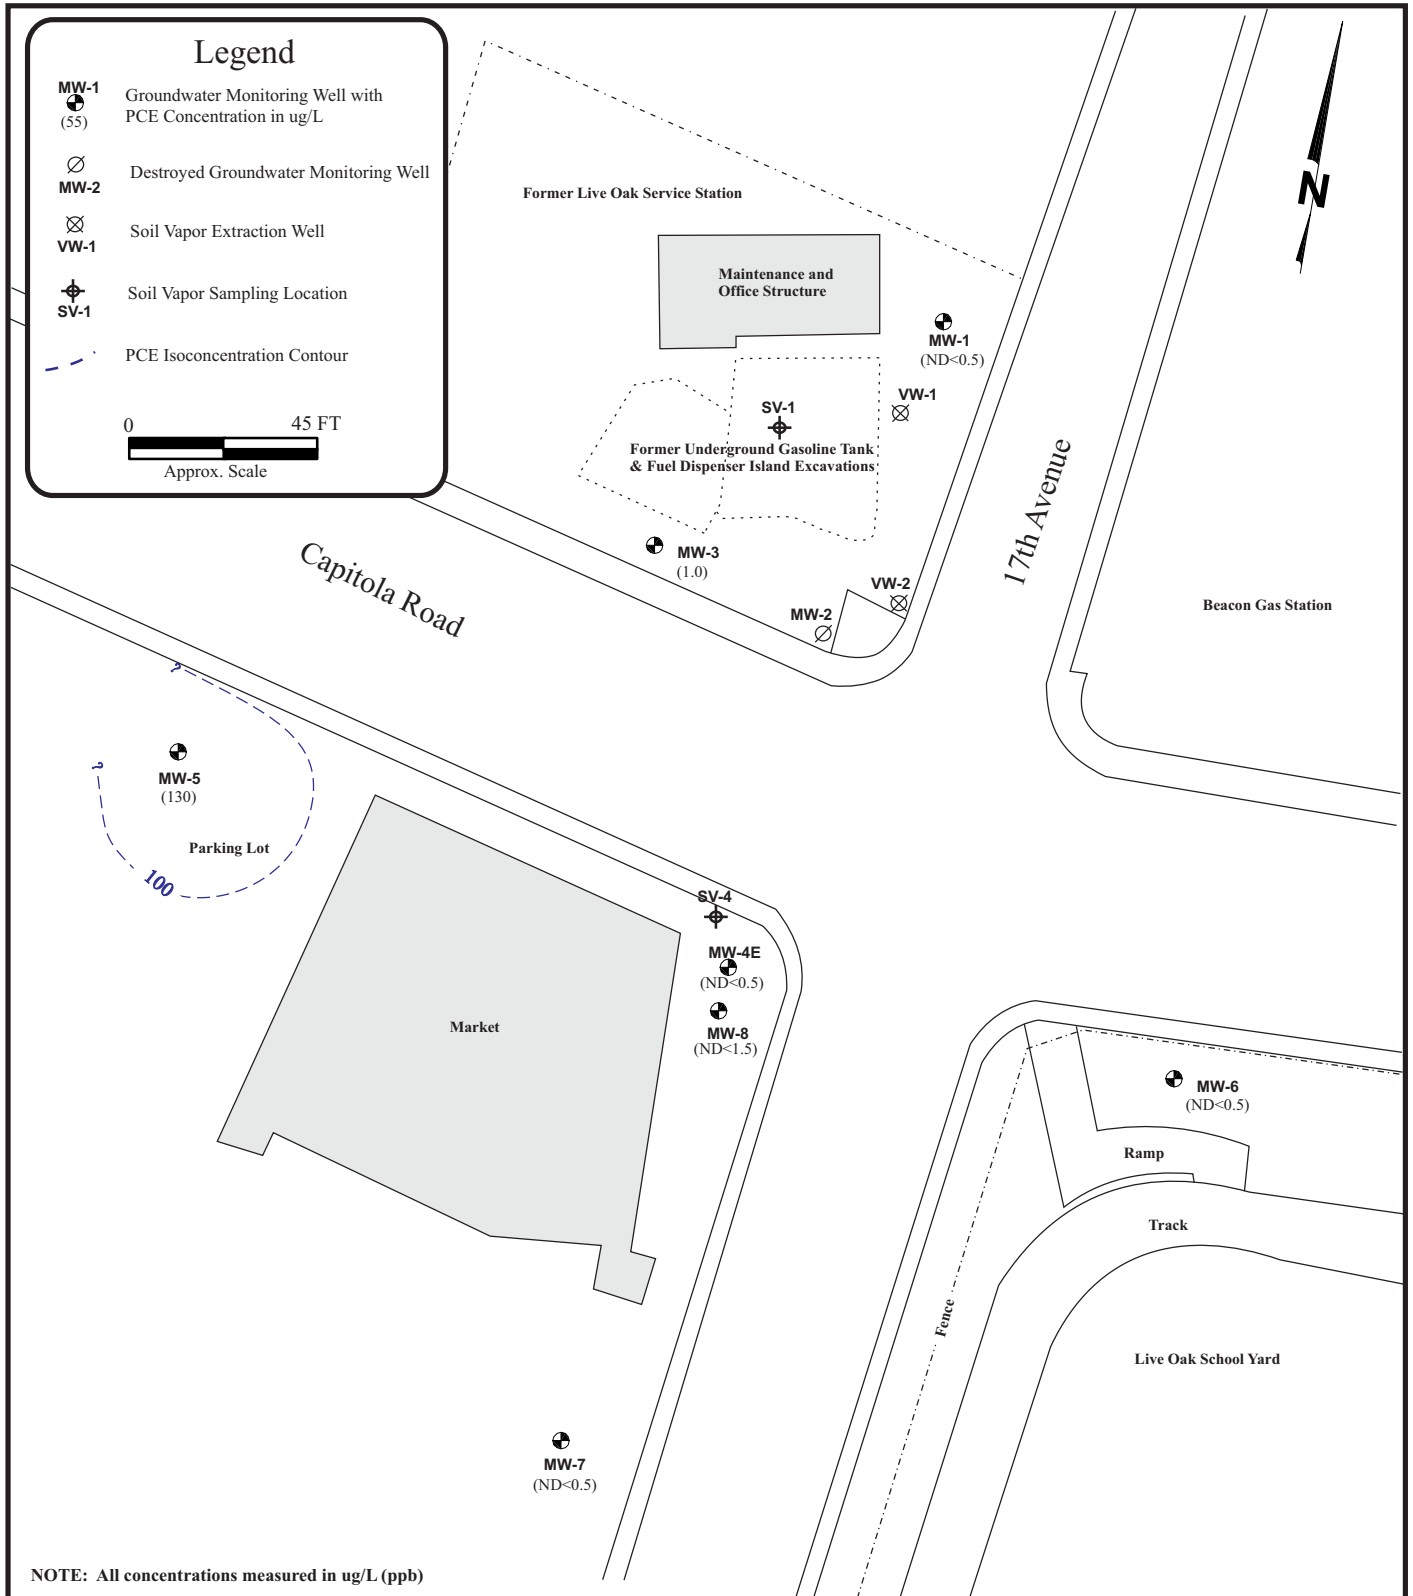
5C

March 18, 2009
PCE Isoconcentration Map

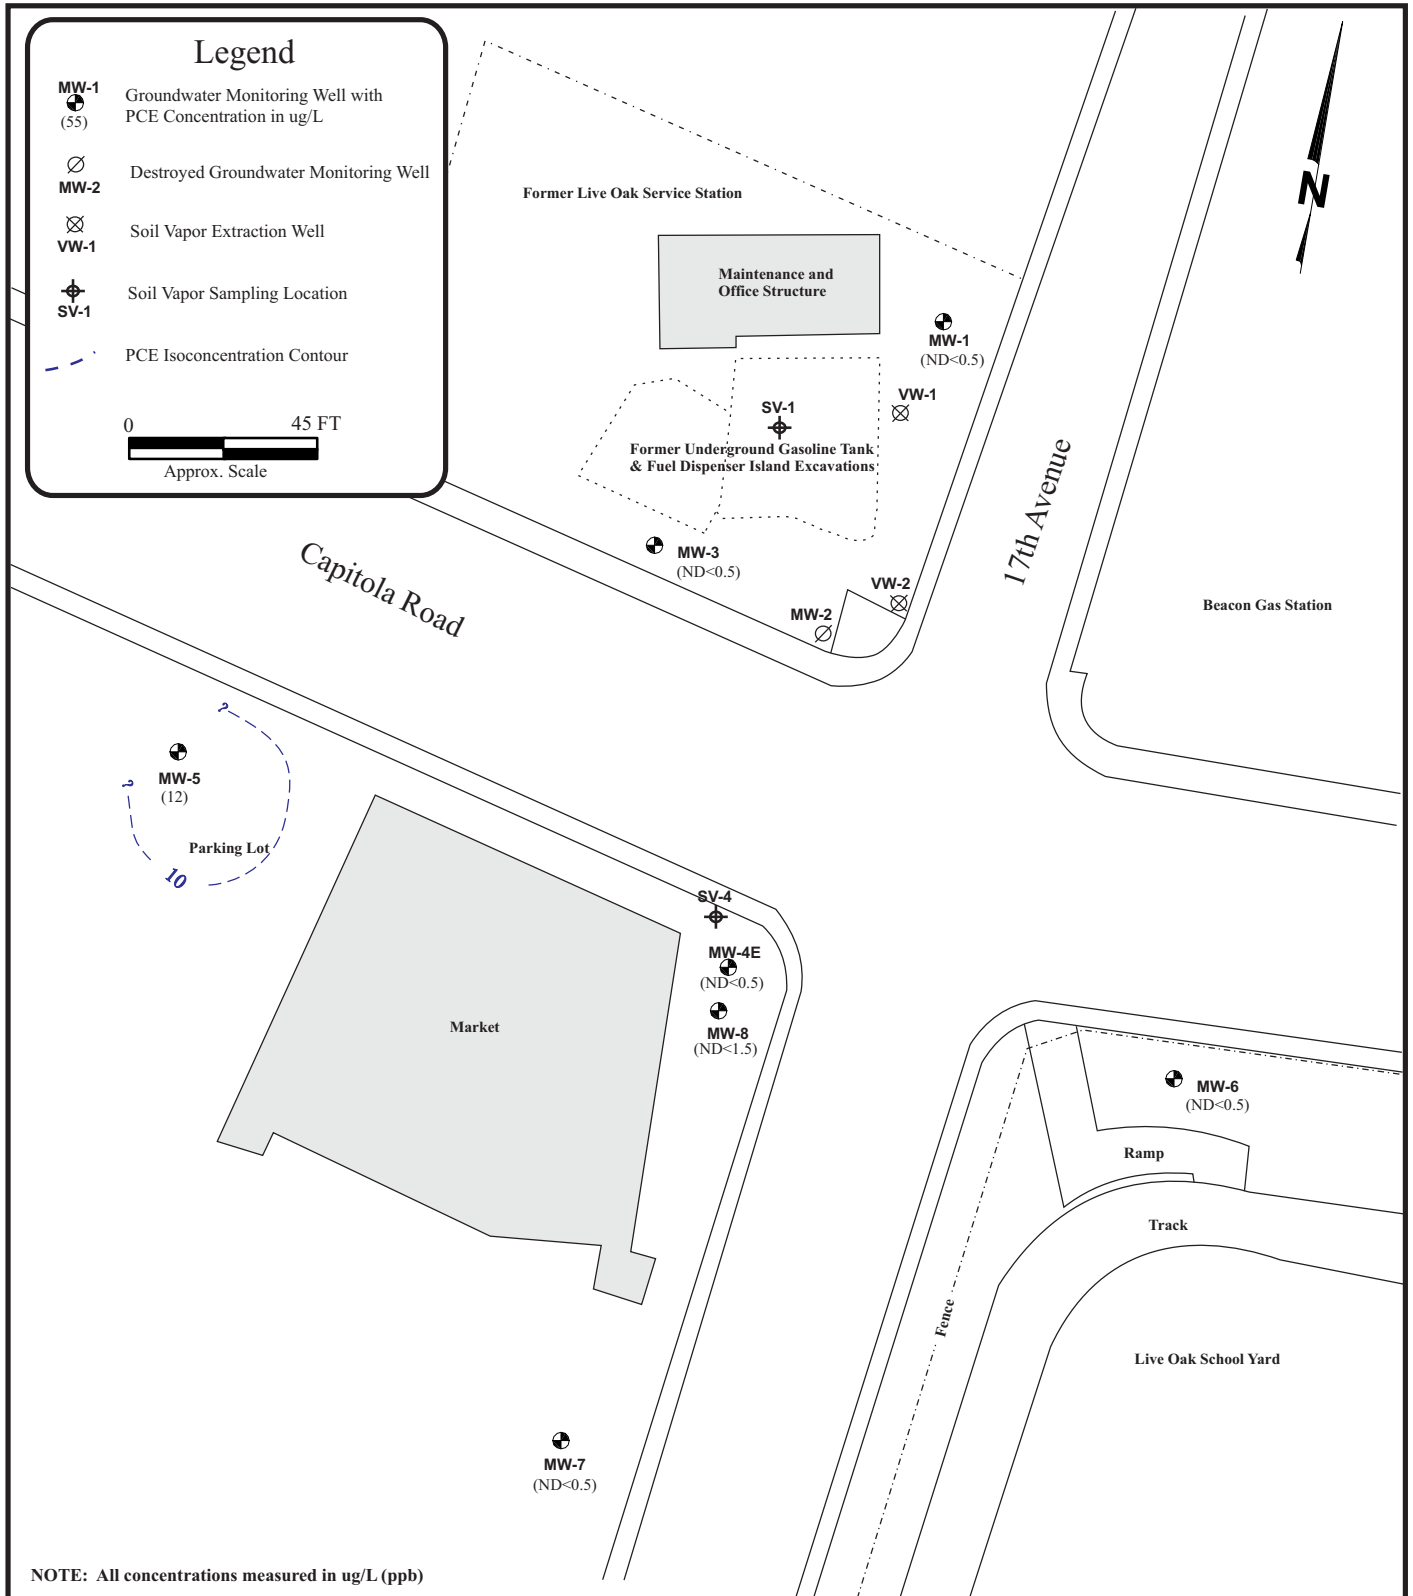
5D

**December 15, 2009
PCE Isoconcentration Map**

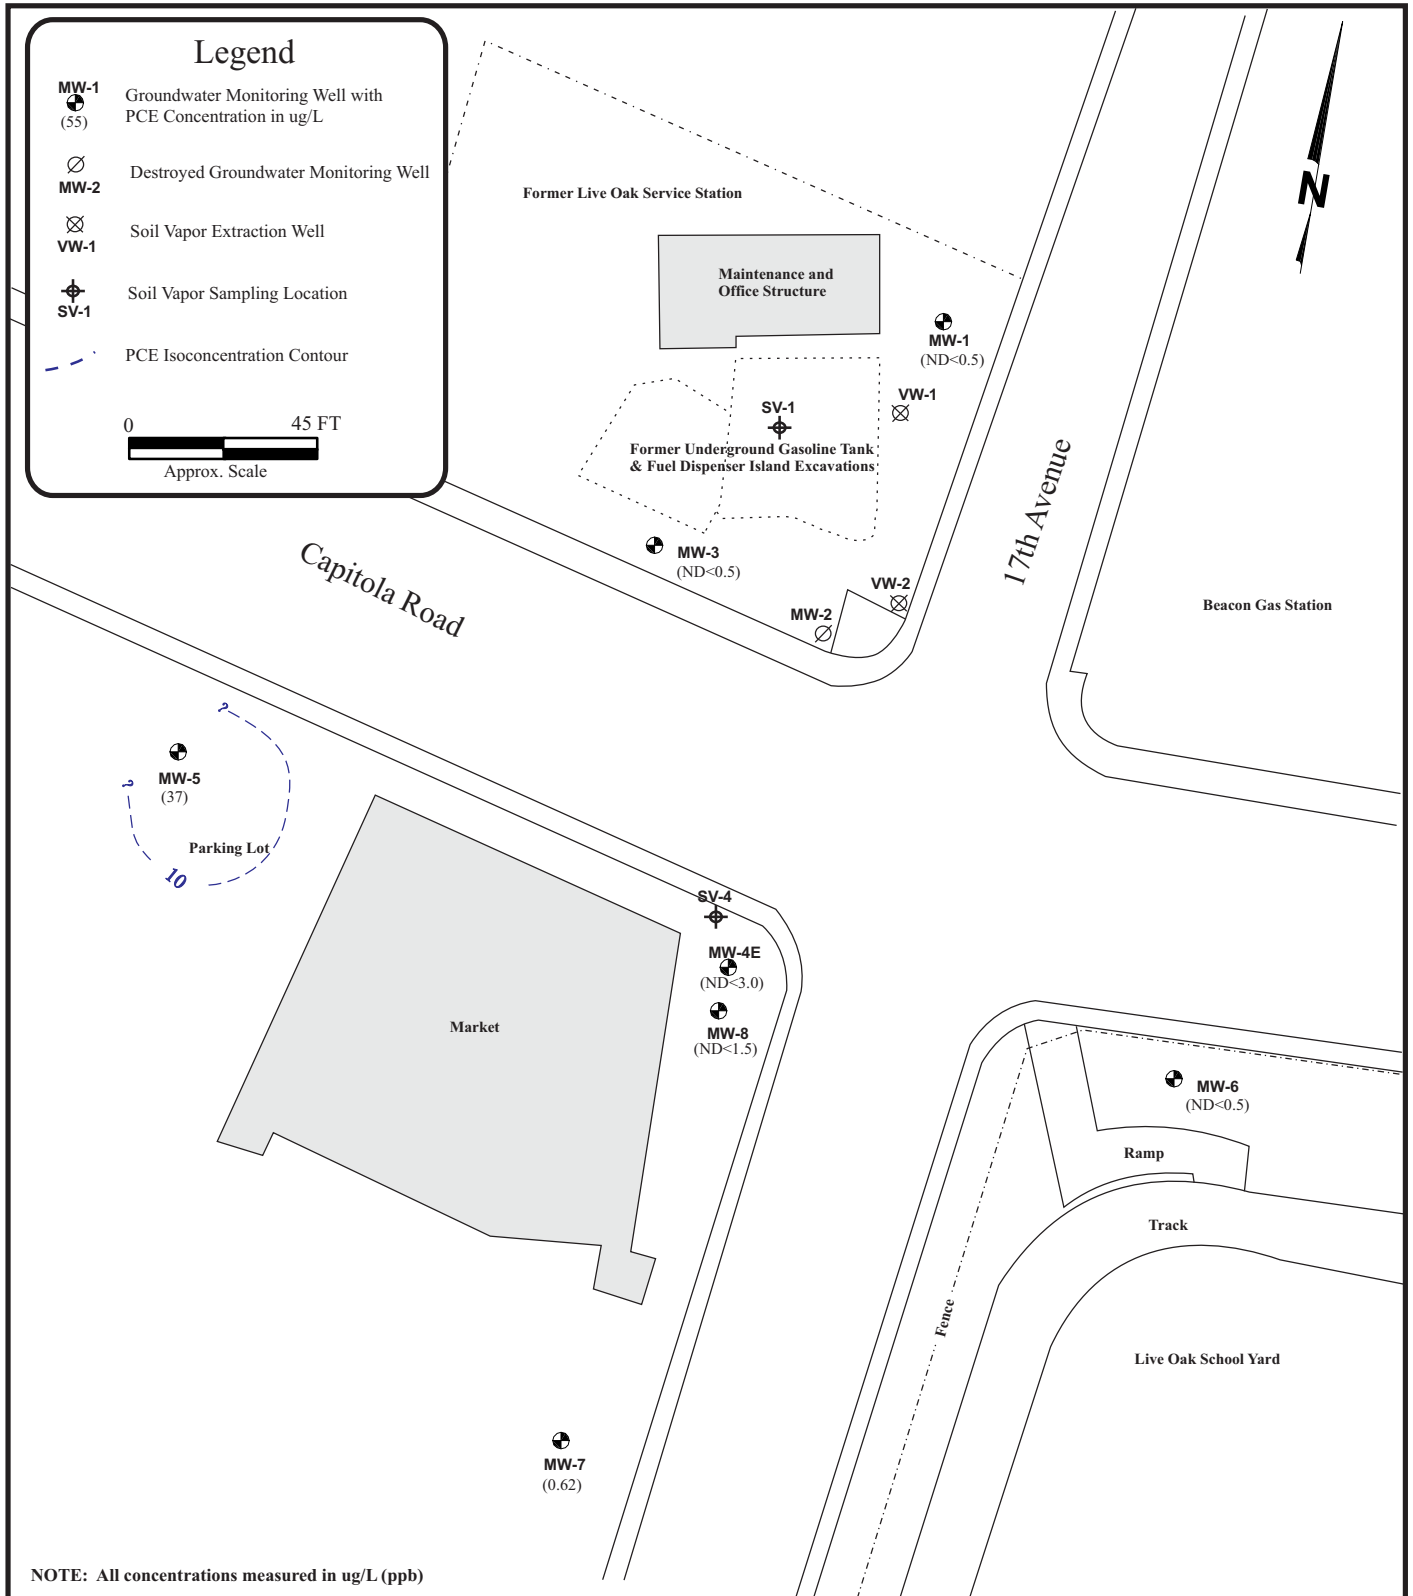
5E

October 22, 2008
 PCE Isoconcentration Map
